AMERICAN ENTERPRISE INSTITUTE
washington, dc

1789 MASSACHUSETTS AVENUE

BUILDING HISTORY

WHAT WE DID

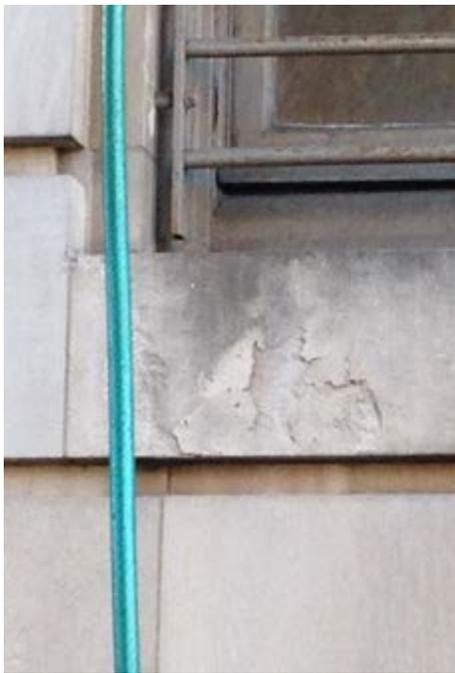
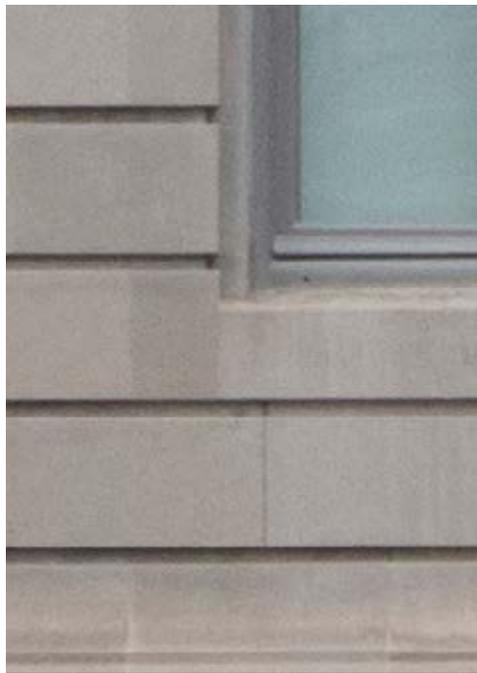
Limestone spalling before construction and after repair.

Much of the building's facade was in good condition with a few exceptions: cracks at window heads, chipped or spalled limestone, inappropriate patching material from previous damage repair, and joints that needed repointing. All of this repair was performed on the limestone facade, granite base, and brick masonry on the alley side of the building. Additionally, the casement windows were refurbished including painting, weatherstripping, wood repair, and the original glass was retained and reglazed. Metal windows were replaced with new insulated windows and security bars at the ground floor were removed and granite was repaired where those connections used to be. The profiles of the original windows were maintained as closely as possible.

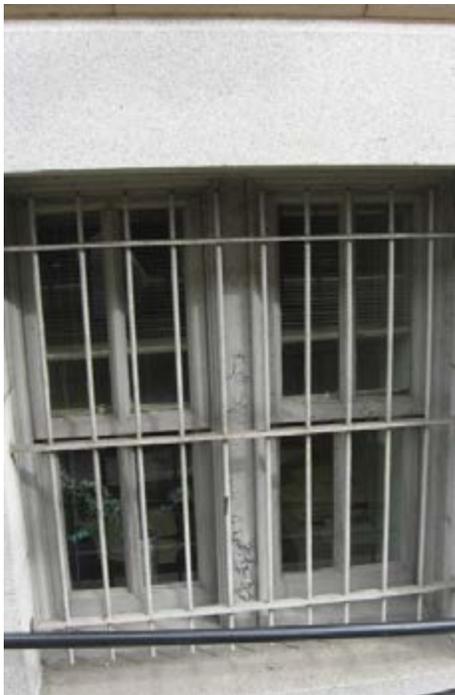
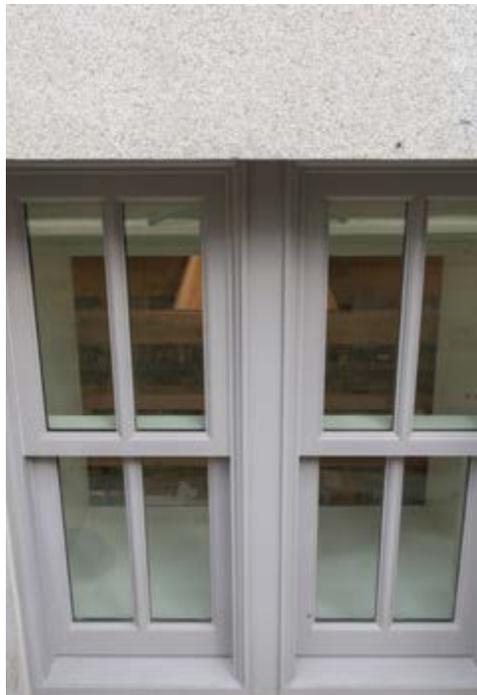
Ground floor metal windows before construction and after replacement with new insulated lites and removal of security bars.

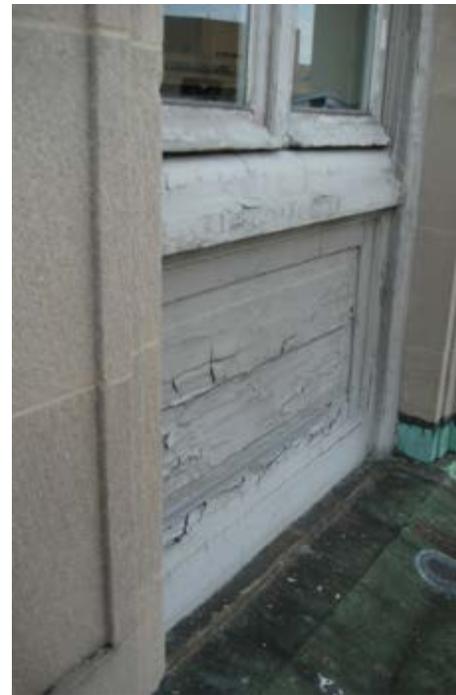
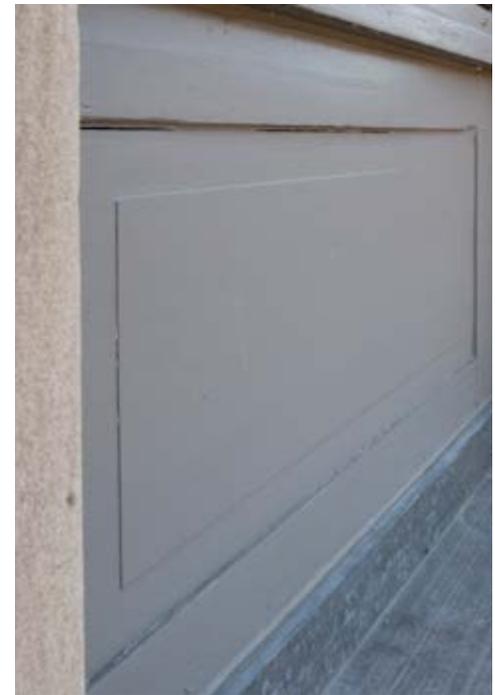
Casement window before construction and after restoration including painting, weatherstripping, and wood repair.

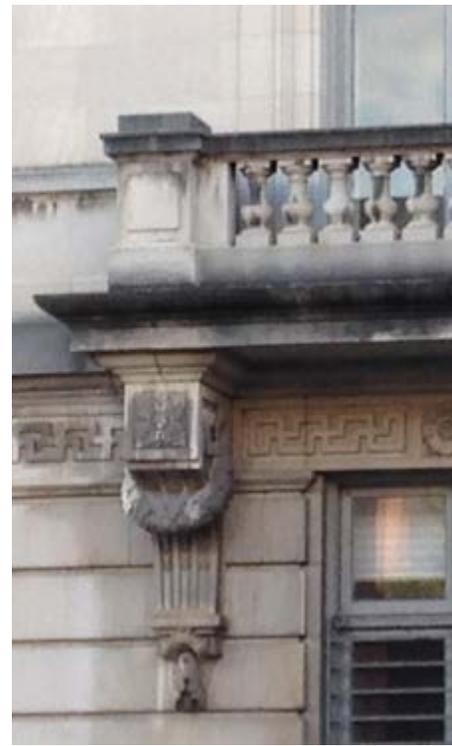
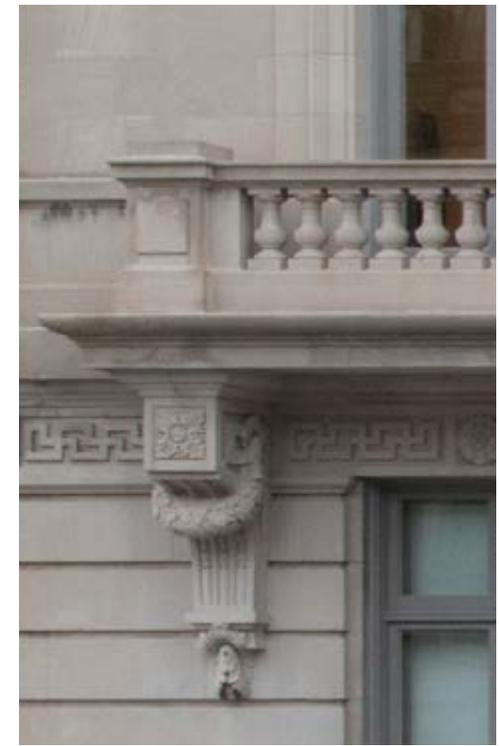
▲ before cleaning

▲ after cleaning

The exterior facade of the building is limestone veneer with rusticated first floor and dressed limestone at the second through fourth floors with carved window and door surrounds. Projecting balconies at the second floor have a limestone balustrade that needed cleaning. Samples of cleaning regimens were prepared and tested to determine the most effective, least intrusive means including steam cleaning, mist, hot water, and cold water with soap.

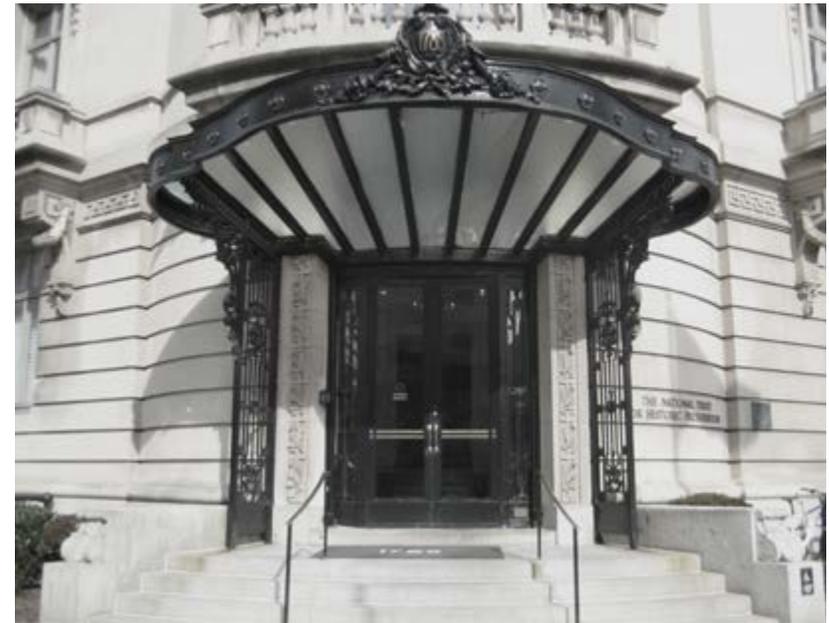
The decorative wrought-iron and glass canopy signals the entry to the building. It was in fair condition, however had broken glazing and the supports were deteriorating. Damaged or broken glazing was repaired/replaced in-kind and the metal was stripped and repainted. The structural integrity of the canopy supports was restored with new metal that matched the original profile.

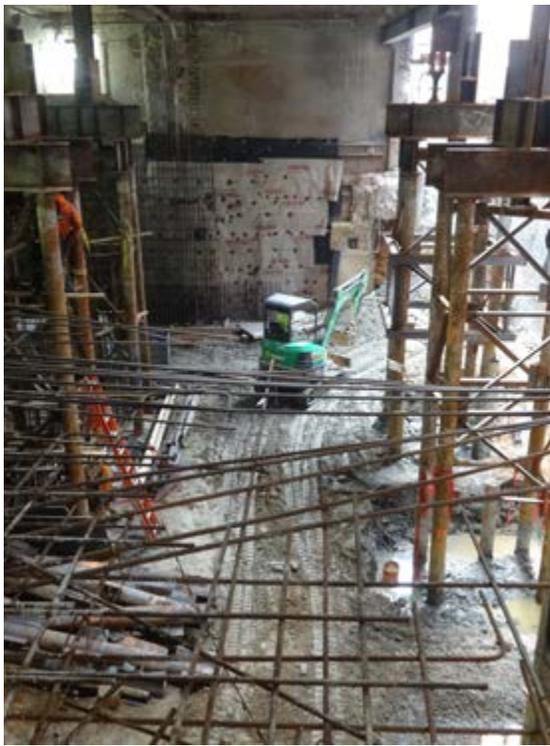
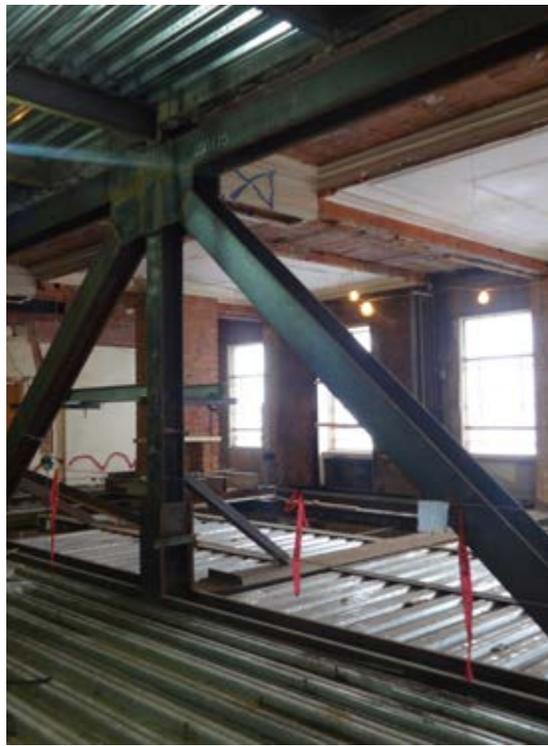
As we began to renovate the building, we found that much of the steel structure was not of the size indicated in the original design documents. To meet code and support the new mechanical penthouse, many of the columns had to be reinforced by painstakingly welding plates on to the existing steel. This, of course, required carefully removing asbestos plaster in those areas.

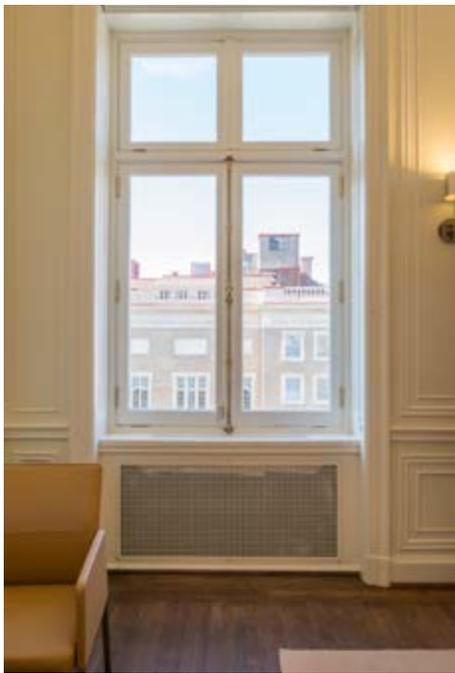
Hot water radiators replaced with variable refrigerant flow fan coil units to provide room temperature control and minimize outside air.

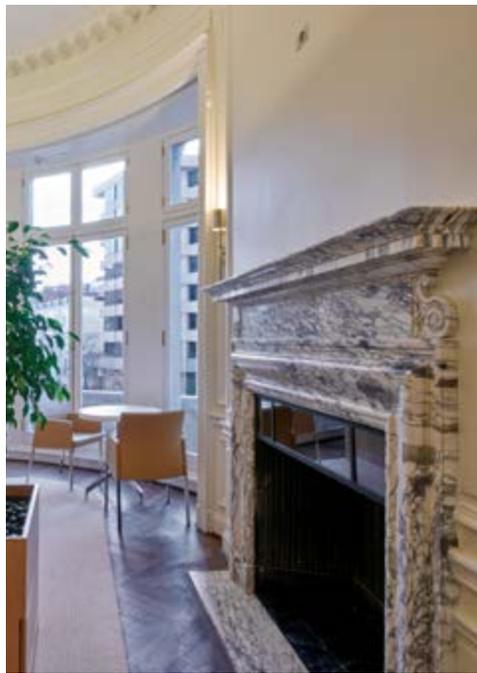
Mantles and fireboxes were cleaned and regouted as required. Loose pieces were attached or pinned.

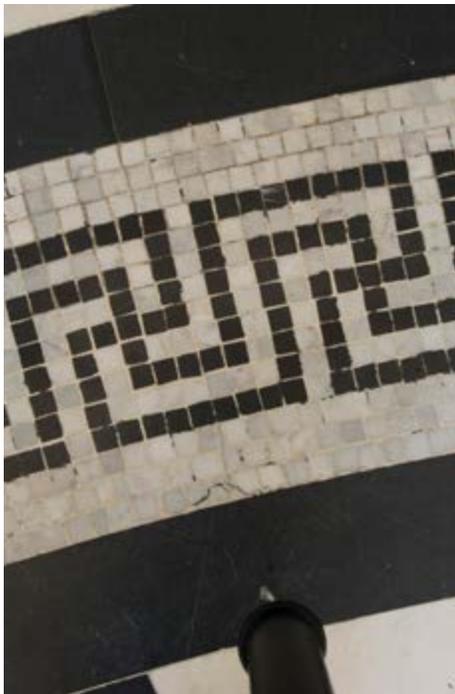
The existing marble flooring was retained, cleaned, and regouted. Loose pieces were also reattached.

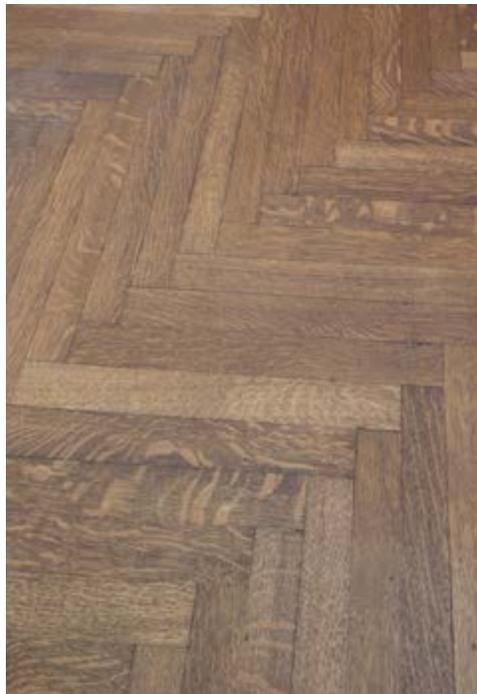
Herringbone White Oak flooring was retained, cleaned, repaired, or replaced in-kind, and refinished.

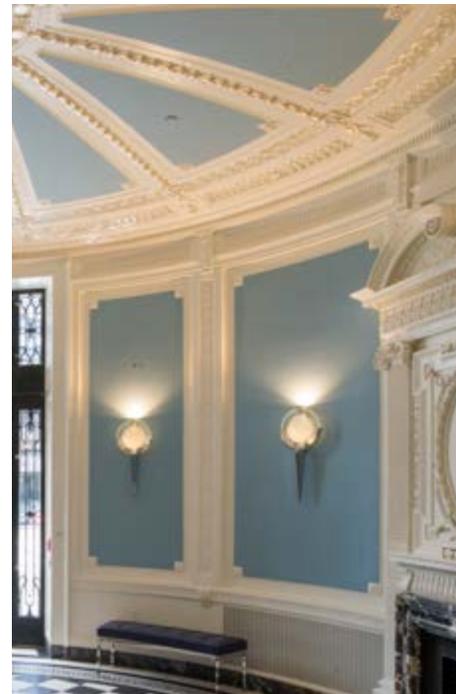
Decorative plaster ceilings retained to extent possible. Repaired, patched, and painted. Molds made from existing to cast missing plaster elements.

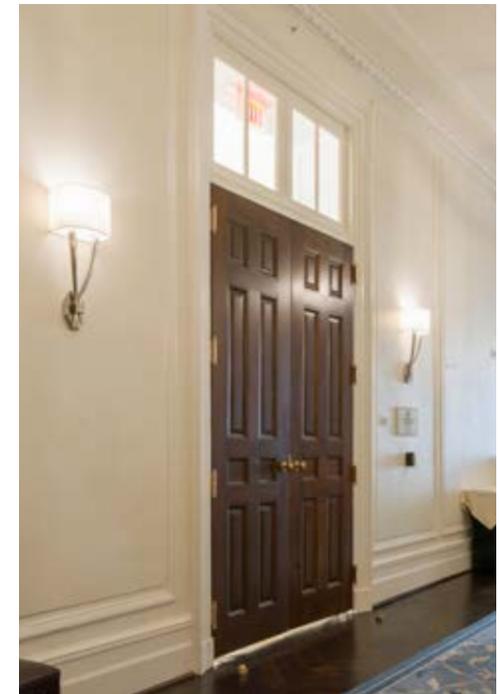
Wood panel door were cleaned and restored. Hardware was retained unless required to be modified to meet code or accessibility.
