Corcoran School of the Arts & Design

The George Washington University

120,000 SF renovation

Principal challenge: Historic Landmark into State-of-the-"Art"

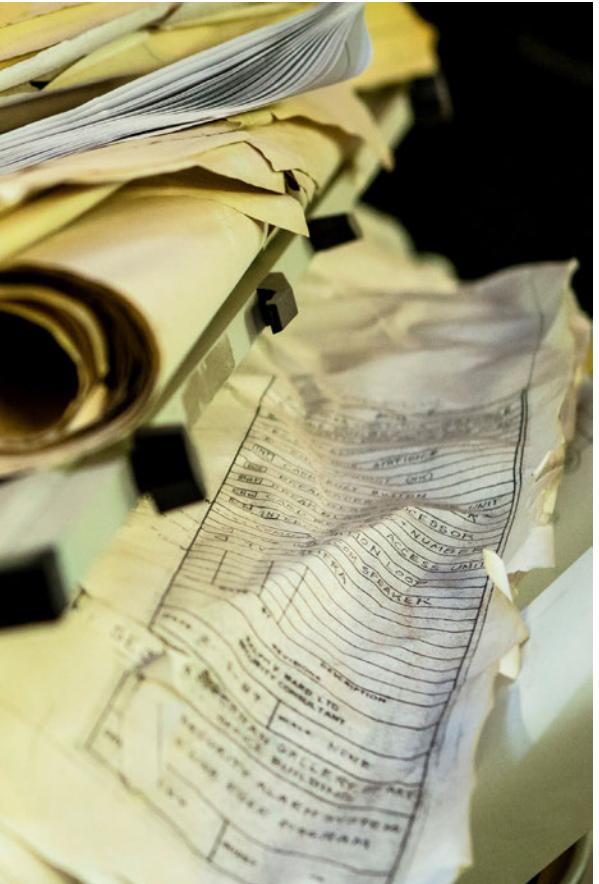
Original plans lost or damaged

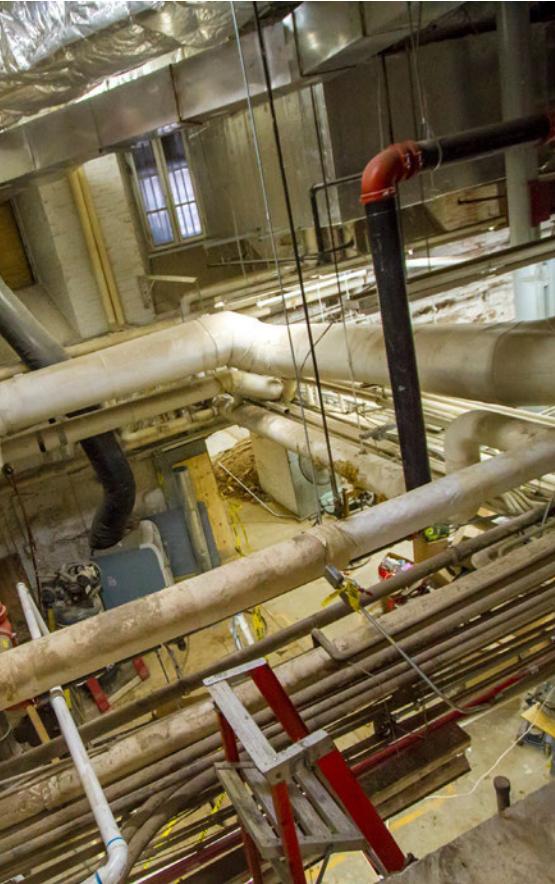
Building systems unlabeled

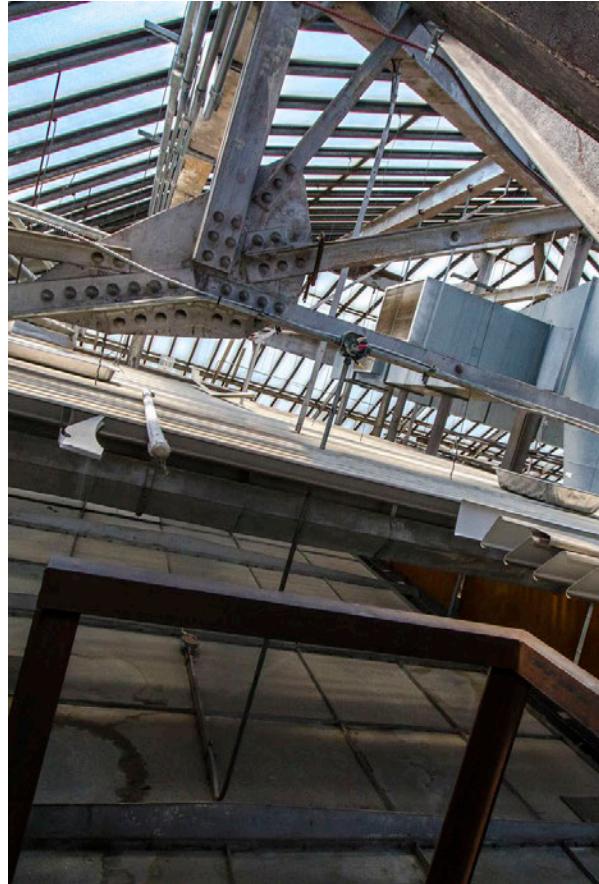
Moisture problems threatened artwork

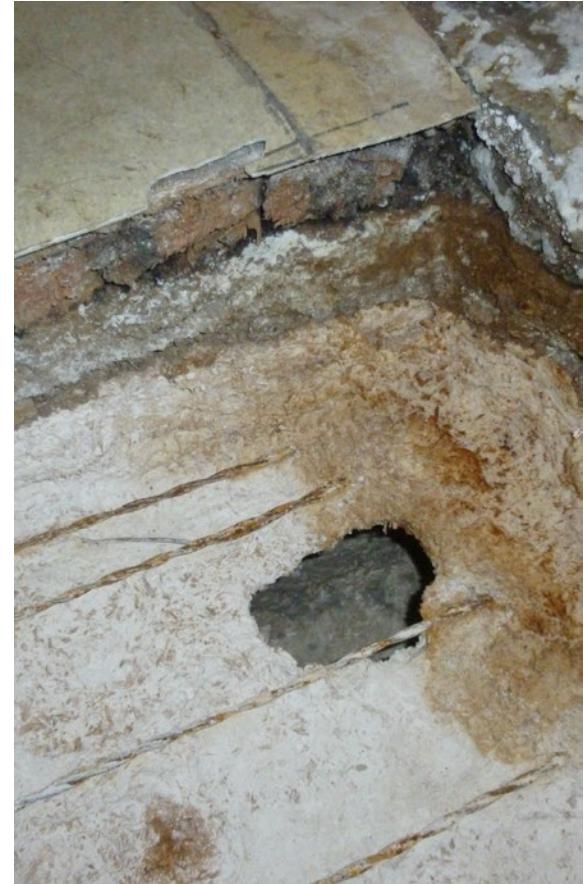
Archaic structural assemblies

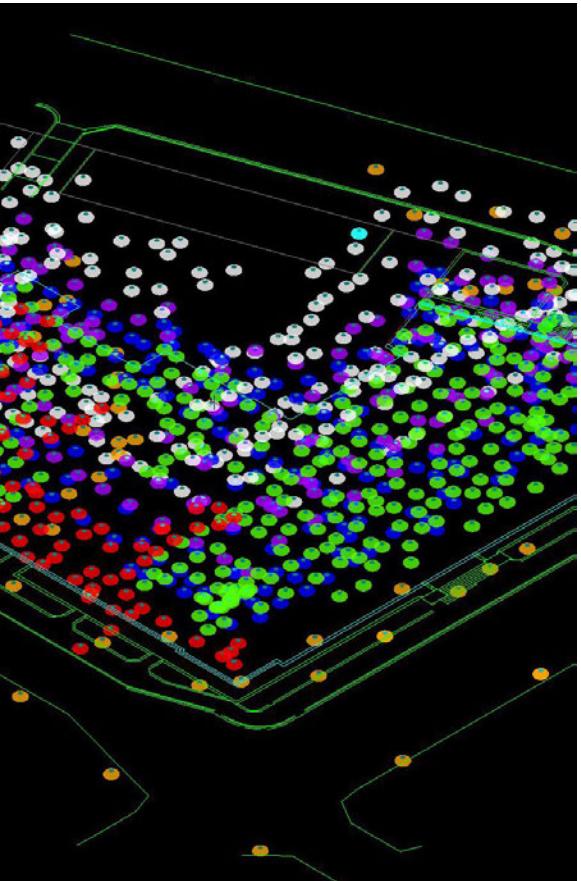
Laser scanning to replace missing as-built drawings

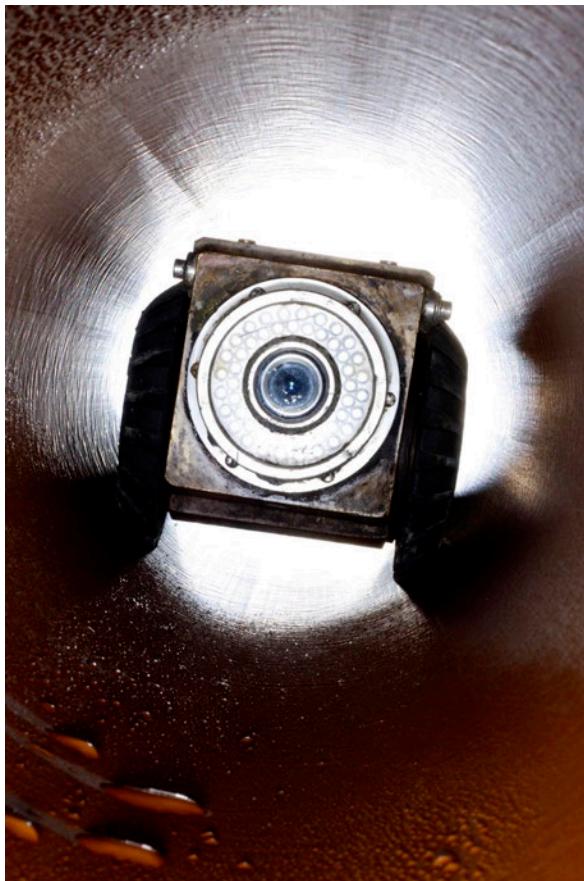
CCTV robots to untangle a maze of building systems from different eras

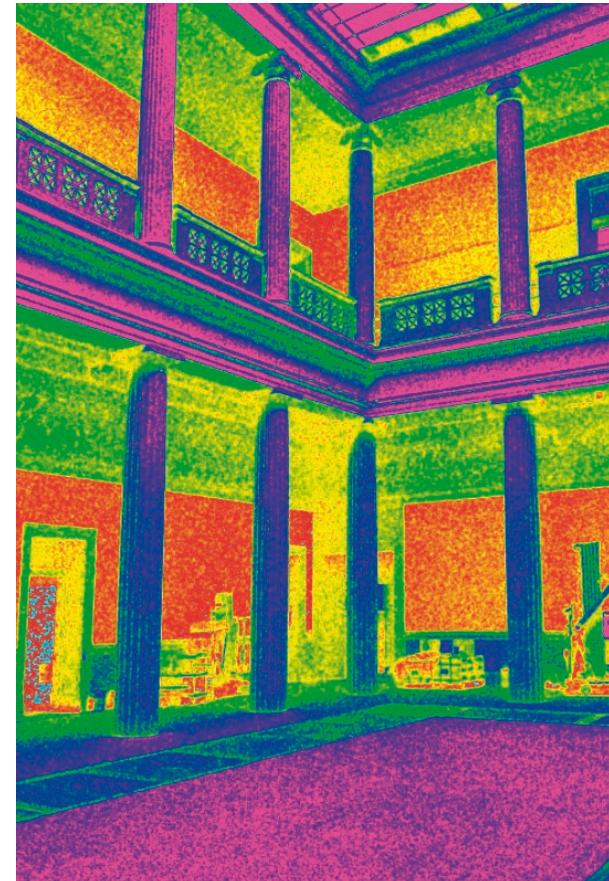
CFD and Hygrothermal analysis to meet NGA art conservation standards

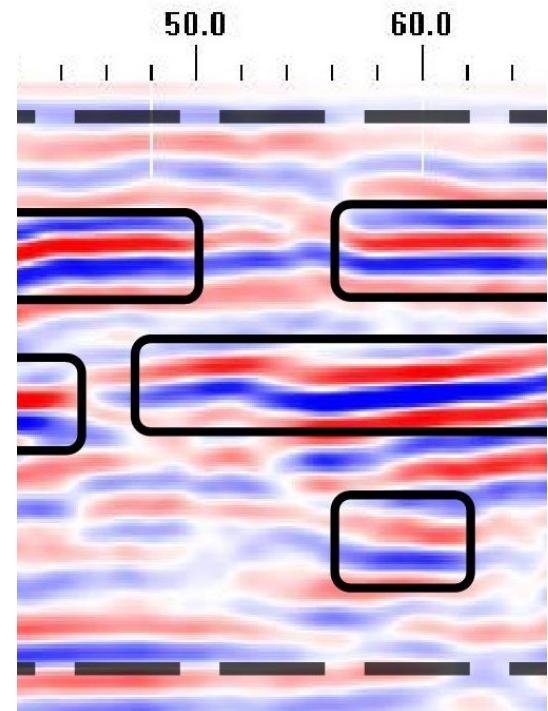
Ground-penetrating radar to document an archaic structural system

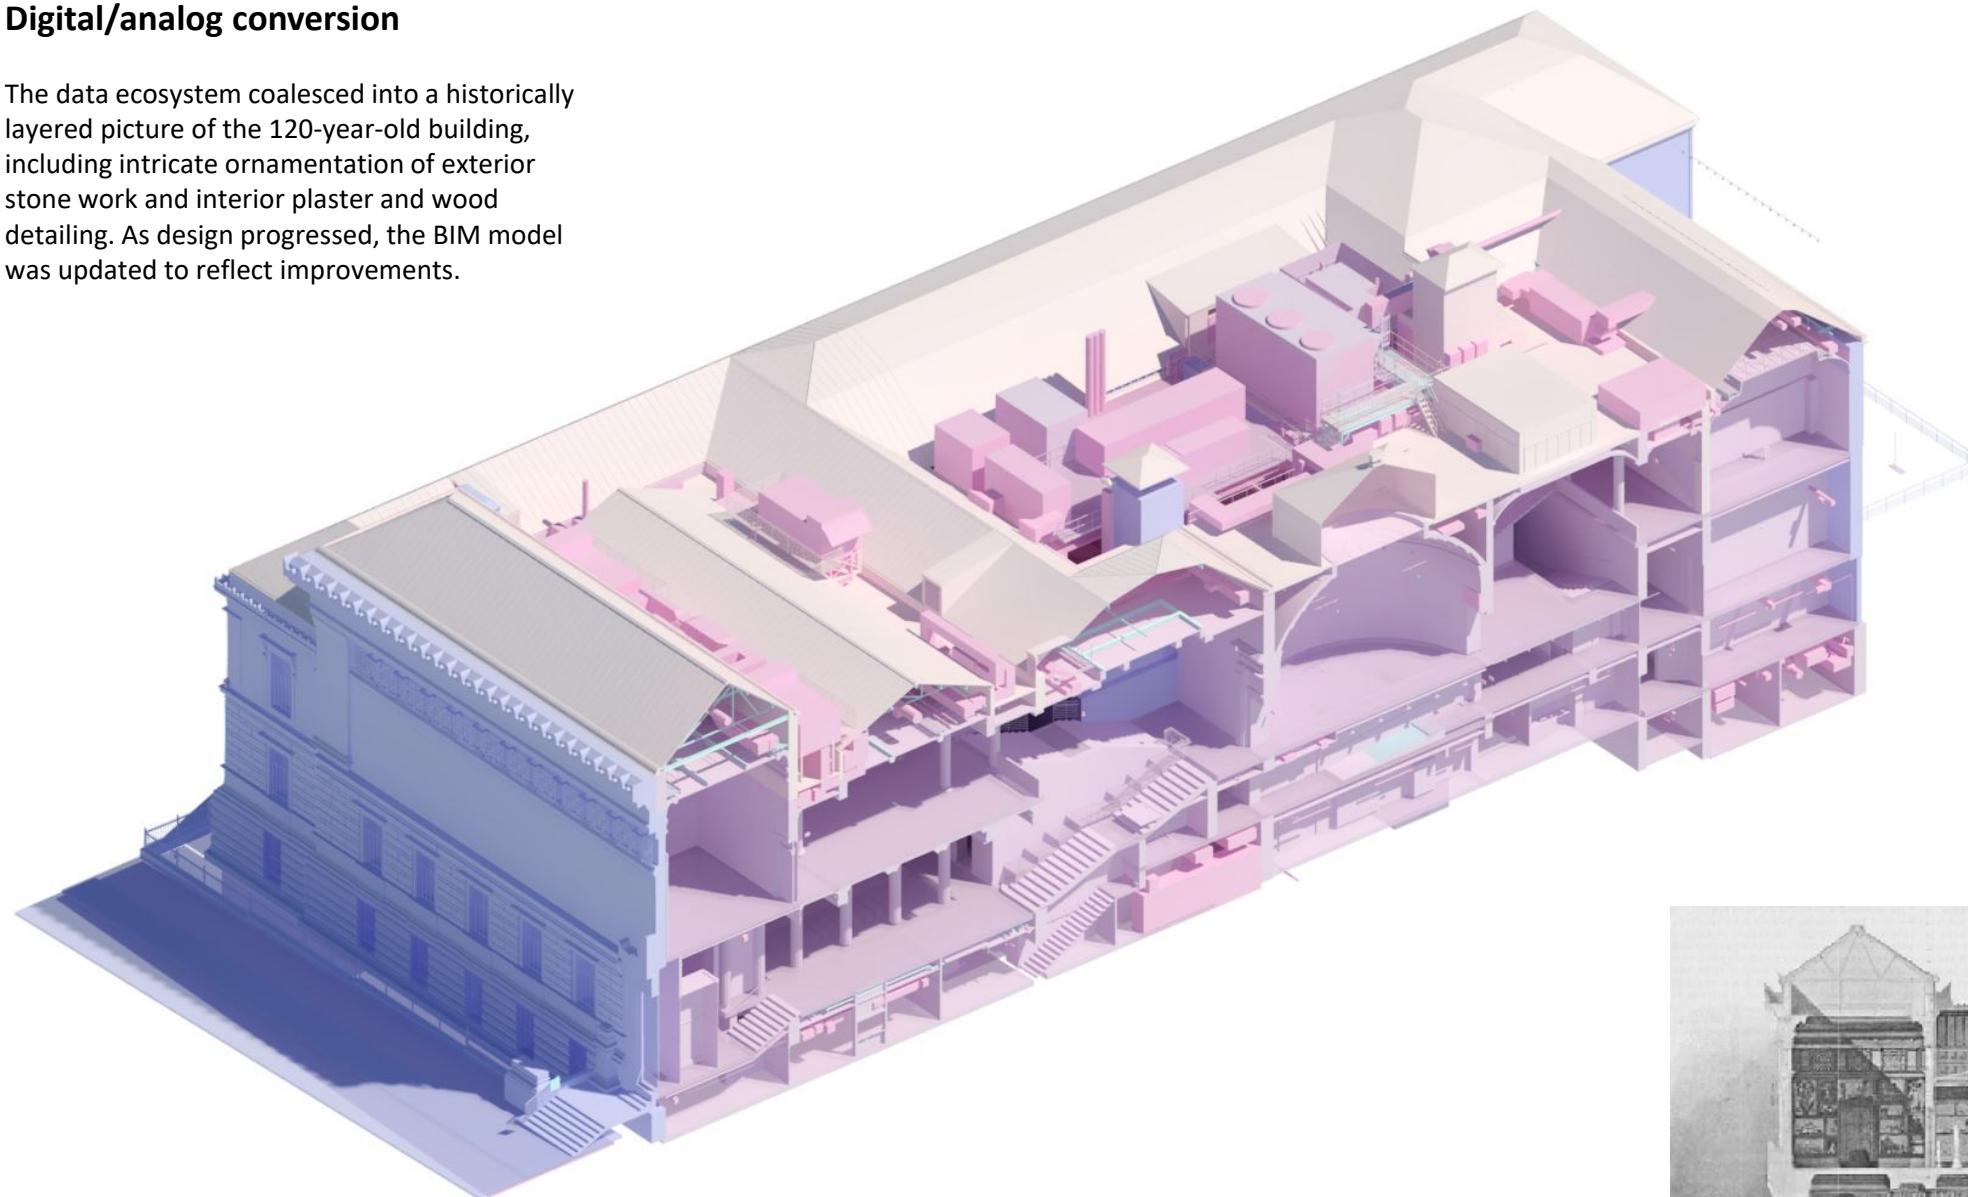
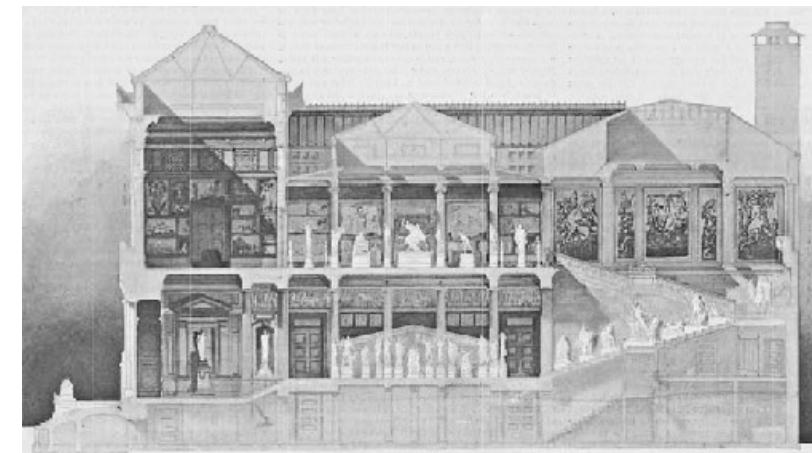
The data ecosystem coalesced into a historically layered picture of the 120-year-old building, including intricate ornamentation of exterior stone work and interior plaster and wood detailing. As design progressed, the BIM model was updated to reflect improvements.

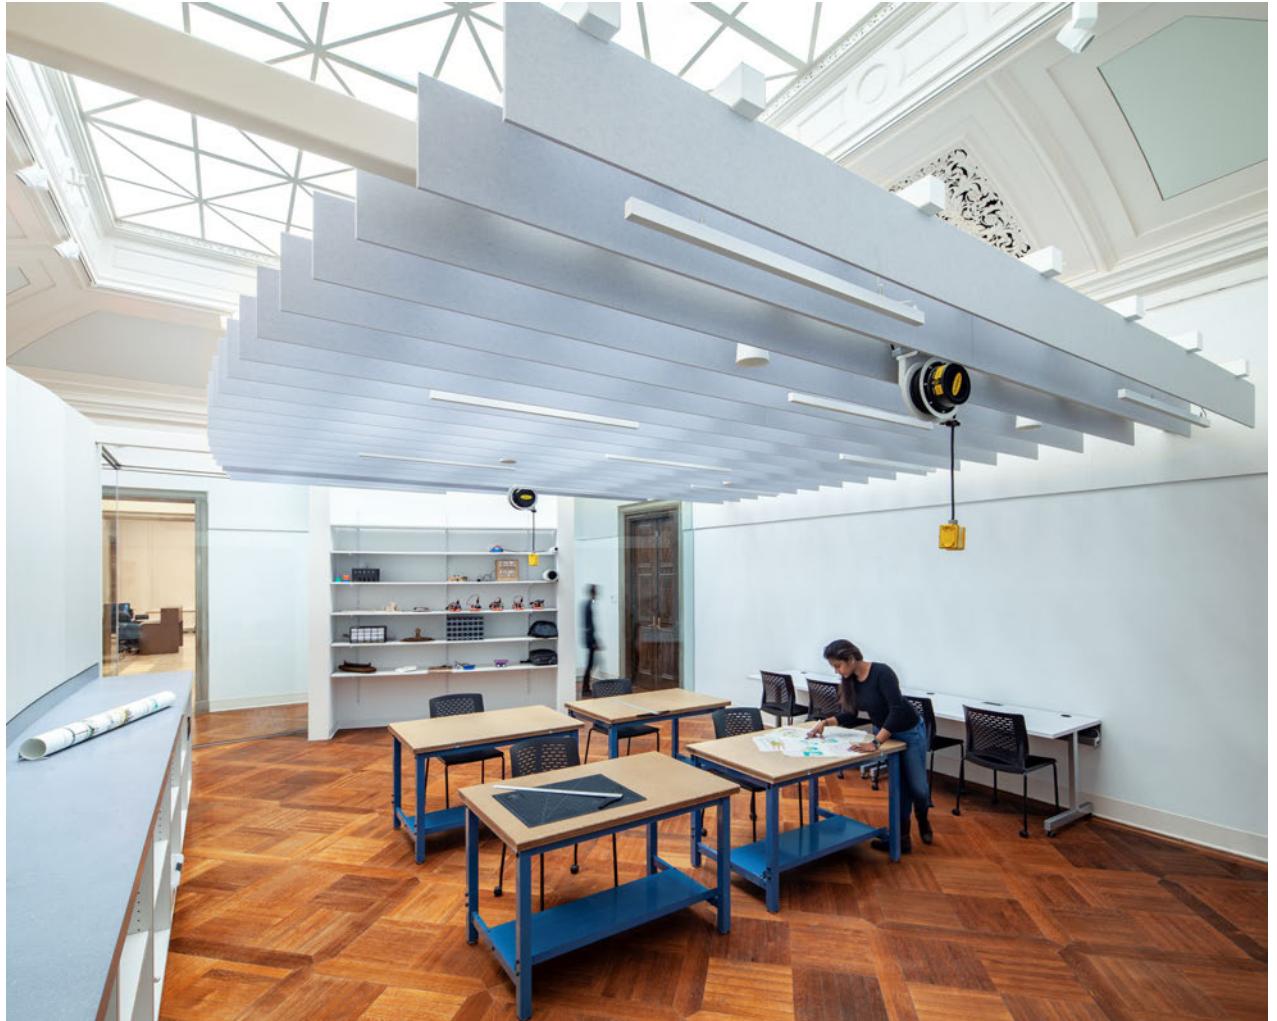
Every intervention reversible

A modern arts-education classroom in a historic shell, created without damage to the historic fabric. Fire suppression systems were surgically installed to preserve delicate plaster detailing and remain out-of-sight. Acoustic clouds create ideal classroom conditions. Restored laylights fill the learning environment with natural light.

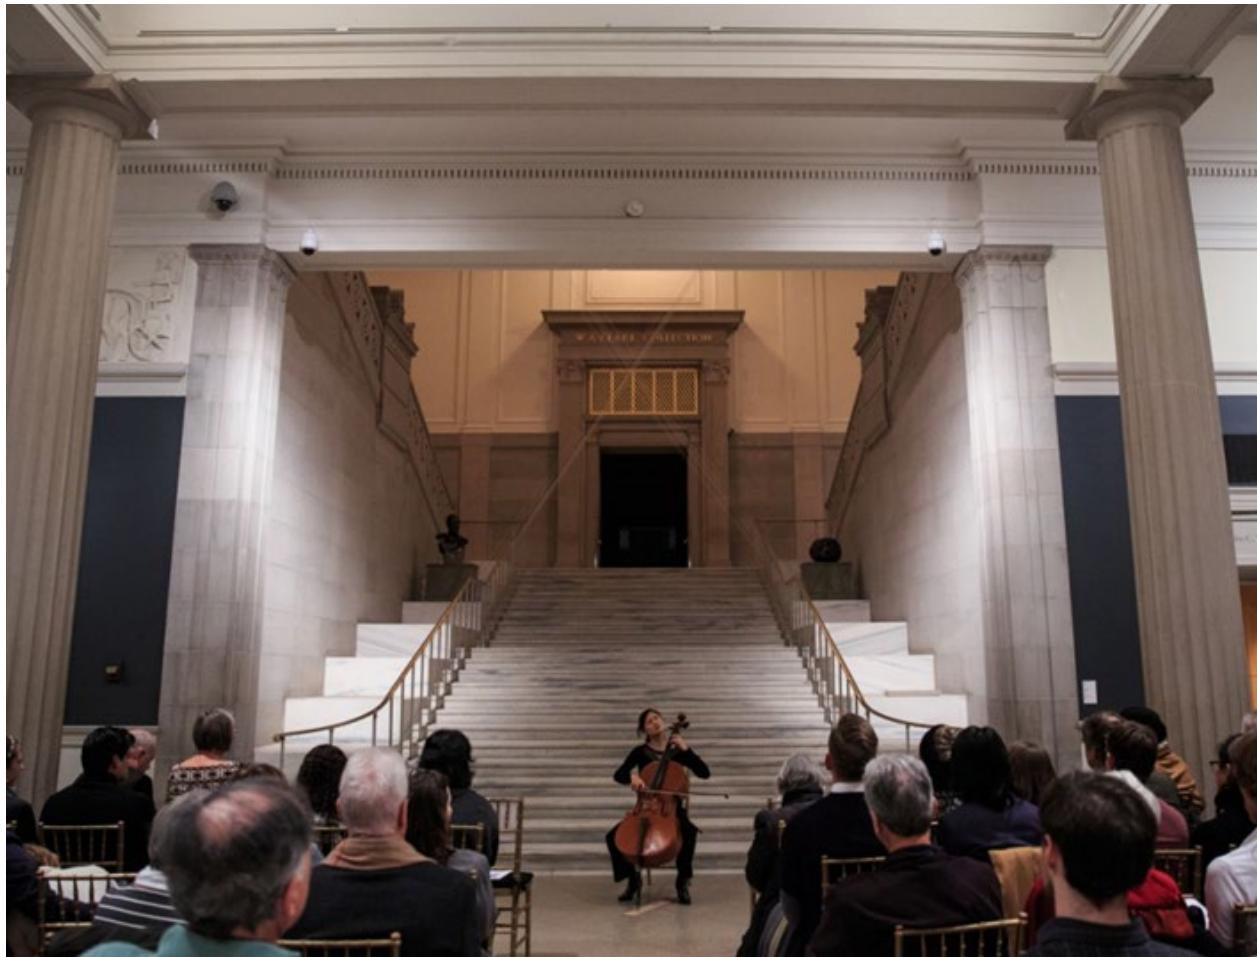
The heart of the Corcoran

The Colonnade is the heart of student life at the Corcoran, featuring exhibitions, musical performances and student gatherings. Perhaps the most dramatic space in the building, it is now returned to its former grandeur. Laylights and skylights above are refurbished, restoring natural light to the space. To accomplish this, all ducts, conduits and piping in the attic have been rerouted with surgical precision.

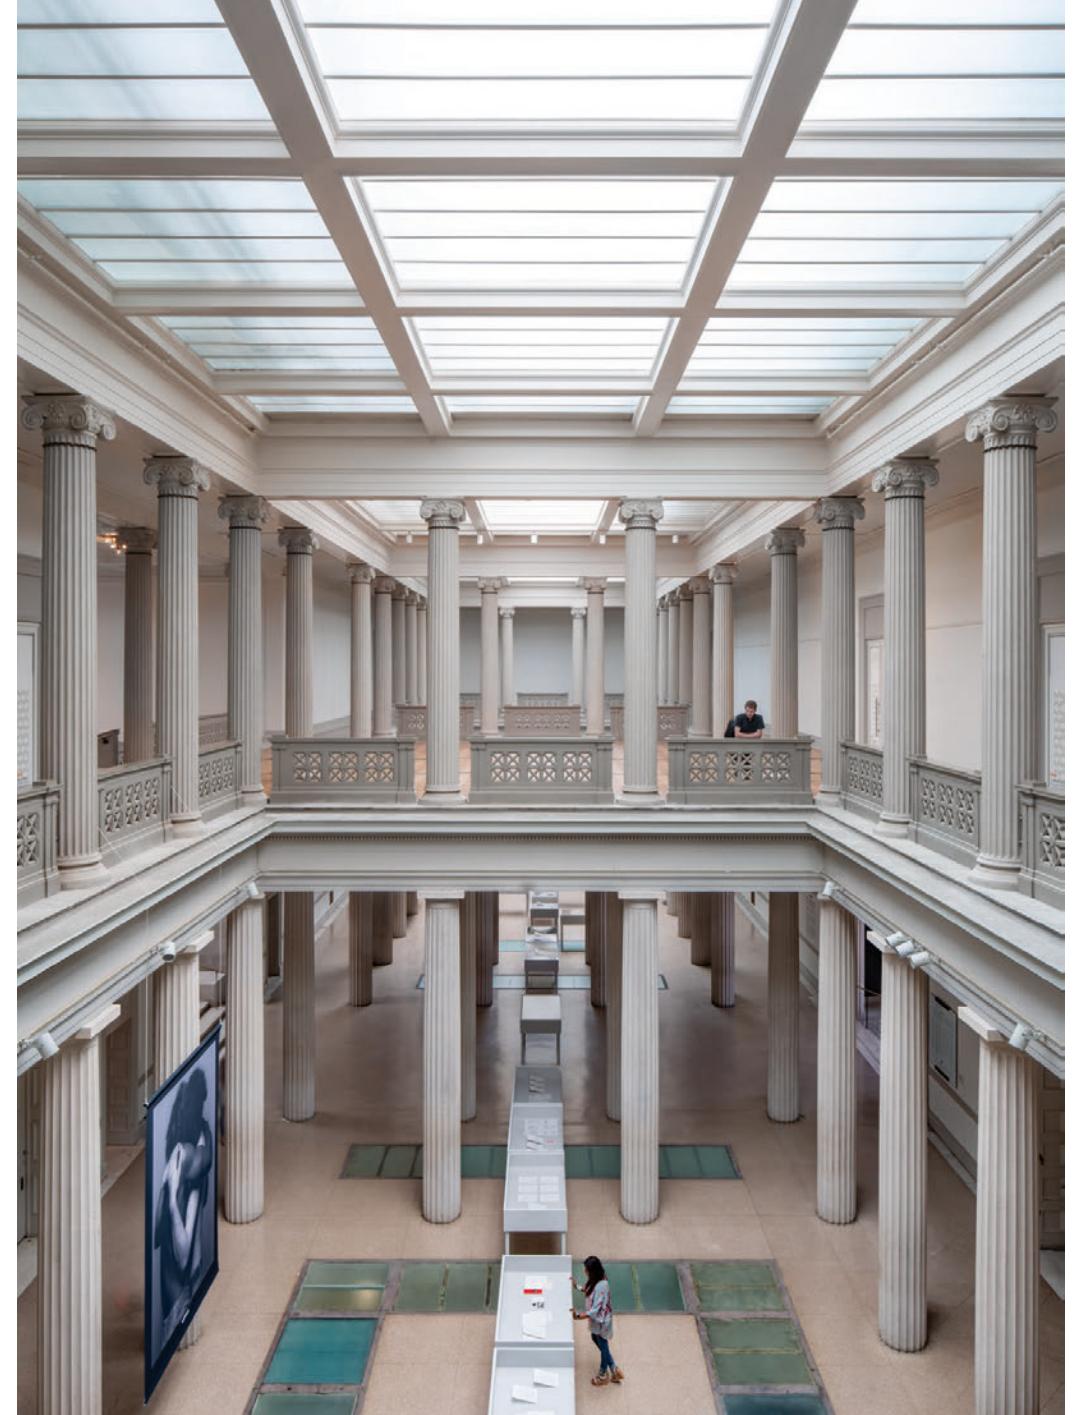
The Rotunda fell into darkness decades ago. The oculus lay lights and skylights above began to deteriorate in the mid-20th century and were covered over to prevent further water infiltration. The lay lights, skylight, coffered ceiling and ornamental plaster work has been refurbished with sprinklers and gallery lighting added.

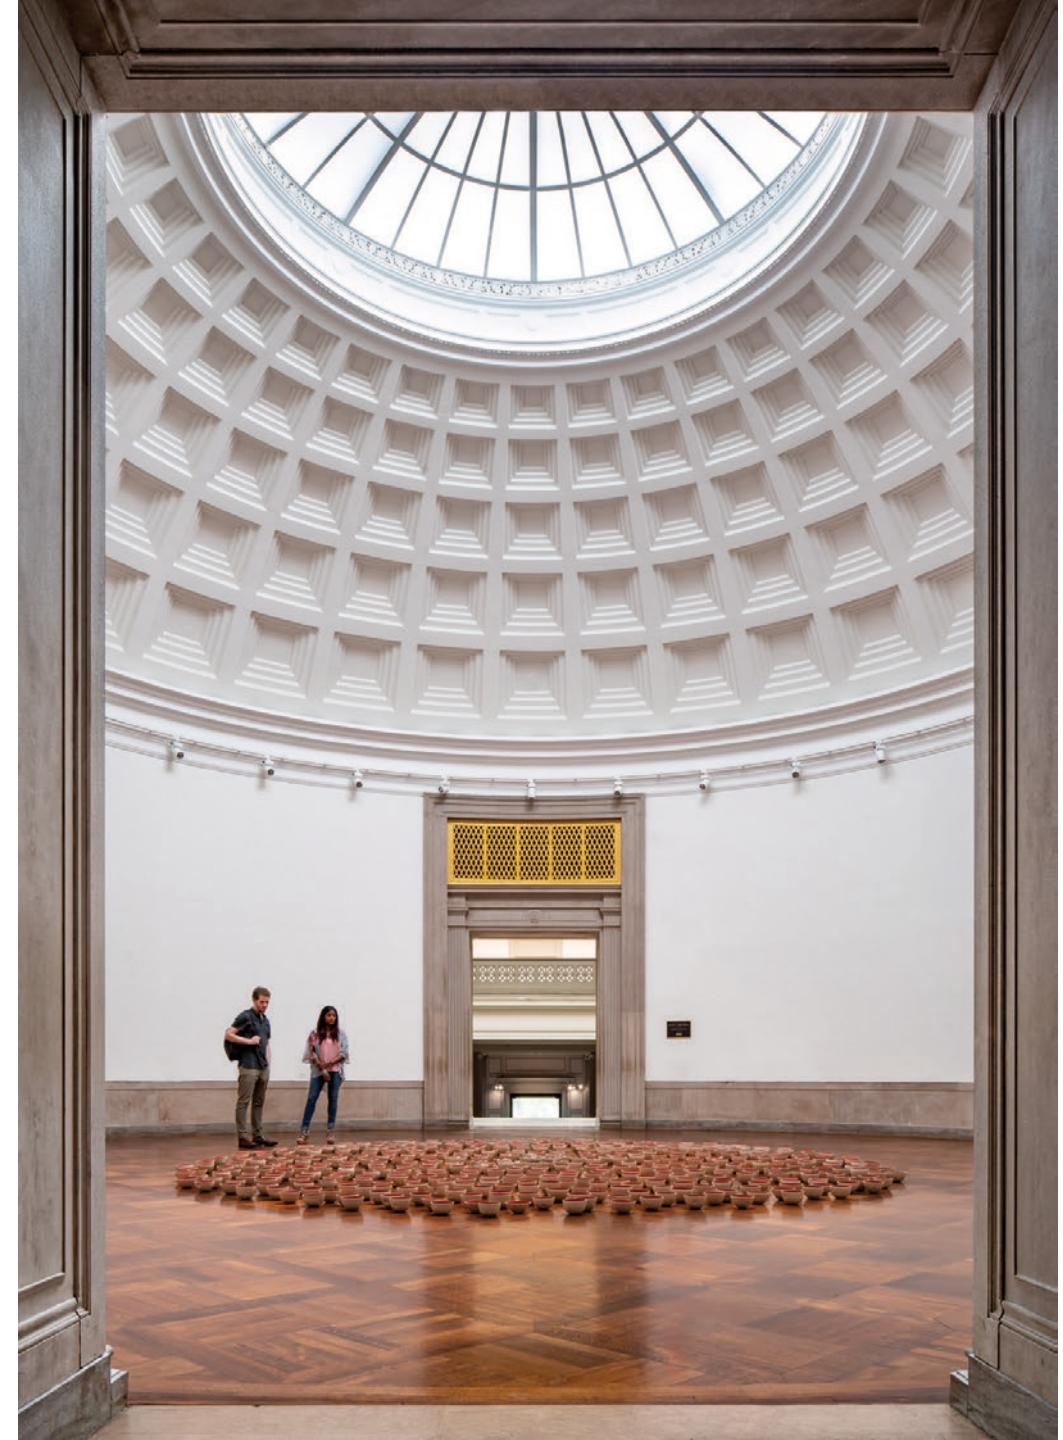
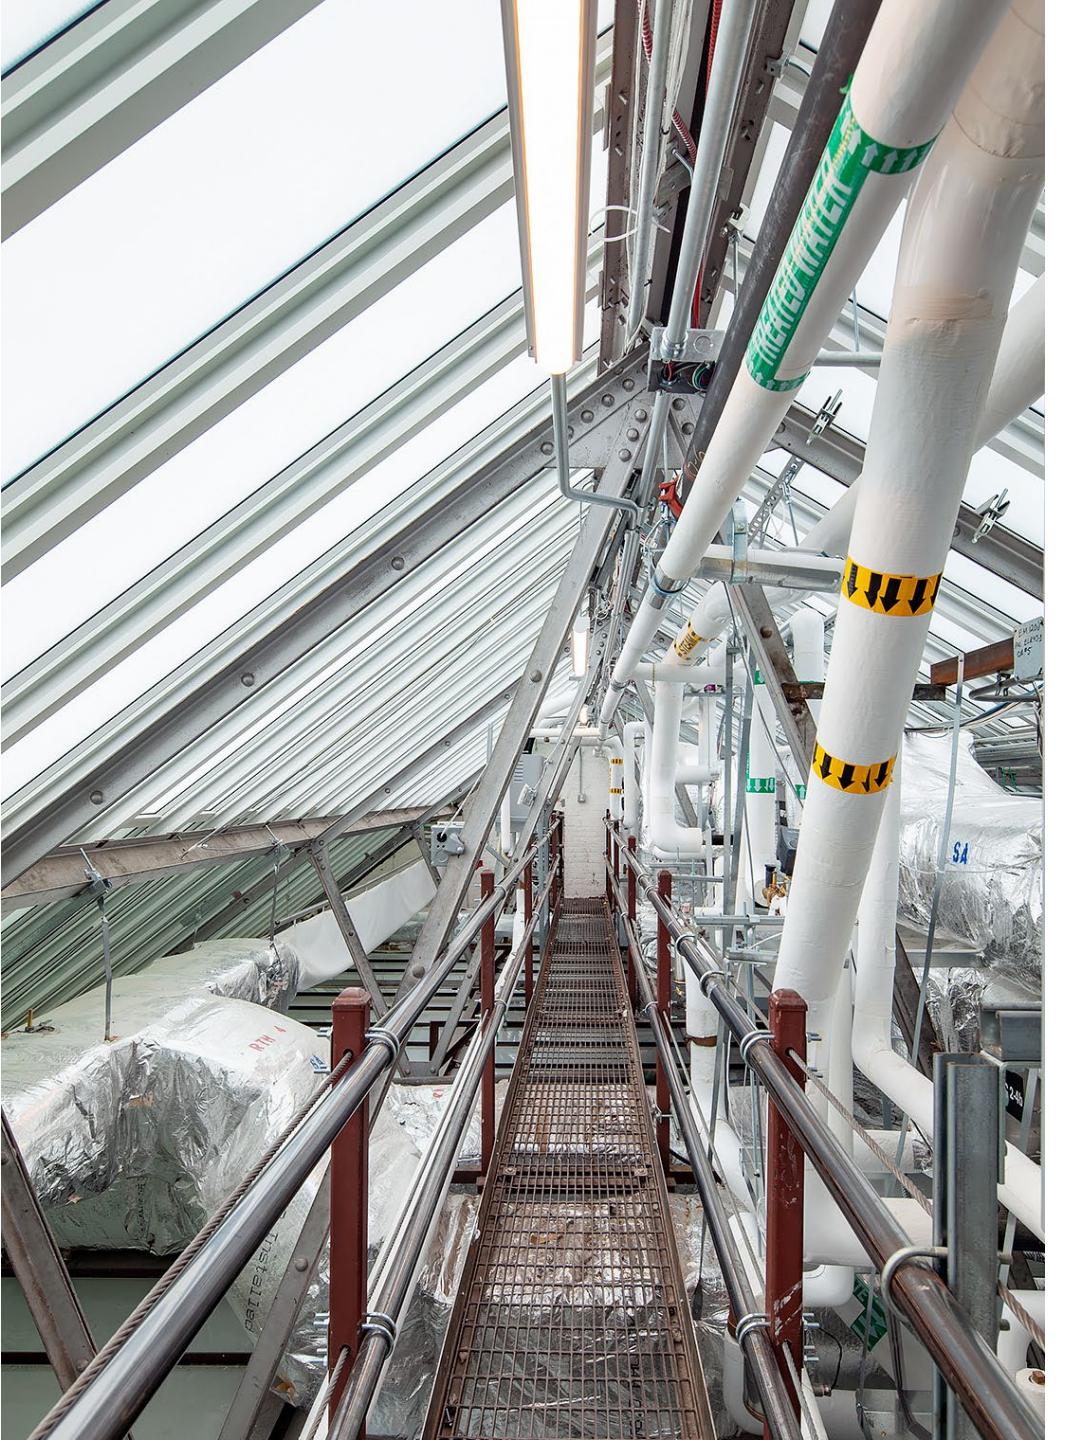
MEP Tetris

Solving the puzzle of how to fit the new, larger mechanical equipment into the minimal space available was central to meeting energy goals and a tight academic program. Space was extremely restricted in the attic, and equipment placed there could not be allowed to block natural daylight into the galleries or create shadows that would affect the viewing of art. Equipment was carefully threaded through the attic in the limited places that are outside the view planes of the original lay lights and skylights in the historic structure.

A sightline easement prevented the installation of a large mechanical penthouse on the roof. The solution was to infill a three-story courtyard with a multi-level equipment platform to house multiple air-handling units, a generator, and an egress stair tower that allows access for maintenance. Below the elevated platform, outdoor units associated with a variable refrigerant flow and heat recovery system serve the basement studios and classrooms, along with outdoor dust-collection units for the sub-basement metal and wood shops.

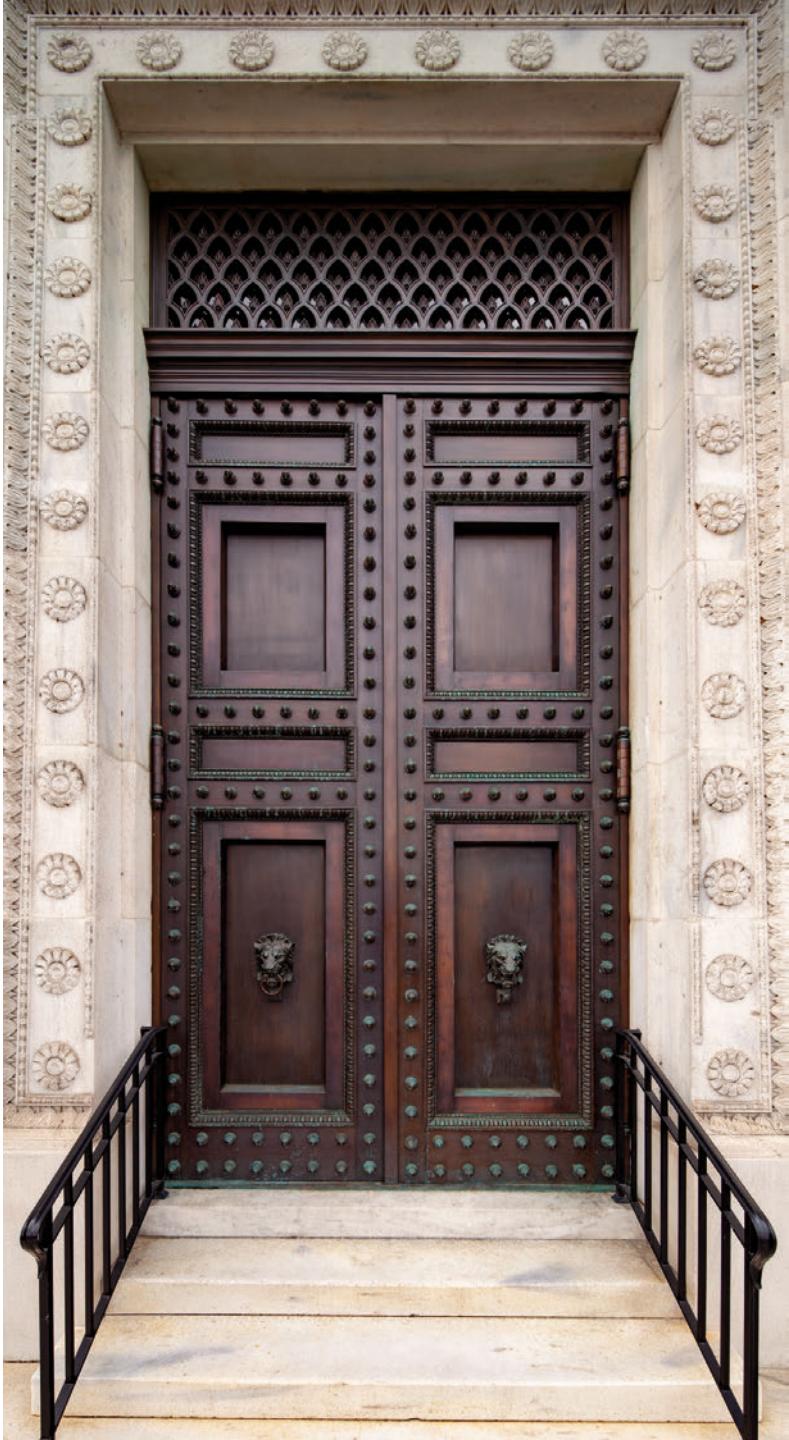
The Corcoran's 17th Street entrance has been returned to prominence under the motto "Dedicated to Art," thanks to careful restoration of its bronze-clad doors. Approximately 4'x16' each, these monumental doors were not operational and permanently fixed in an "open" position when the project began. A glass vestibule inside served as the official entrance. An expert conservator removed the doors, installed a temporary entrance, restored the doors and reinstalled them in an operable condition.
