AMERICAN ENTERPRISE INSTITUTE
washington, dc

1789 MASSACHUSETTS AVENUE

BUILDING HISTORY

WHAT WE DID

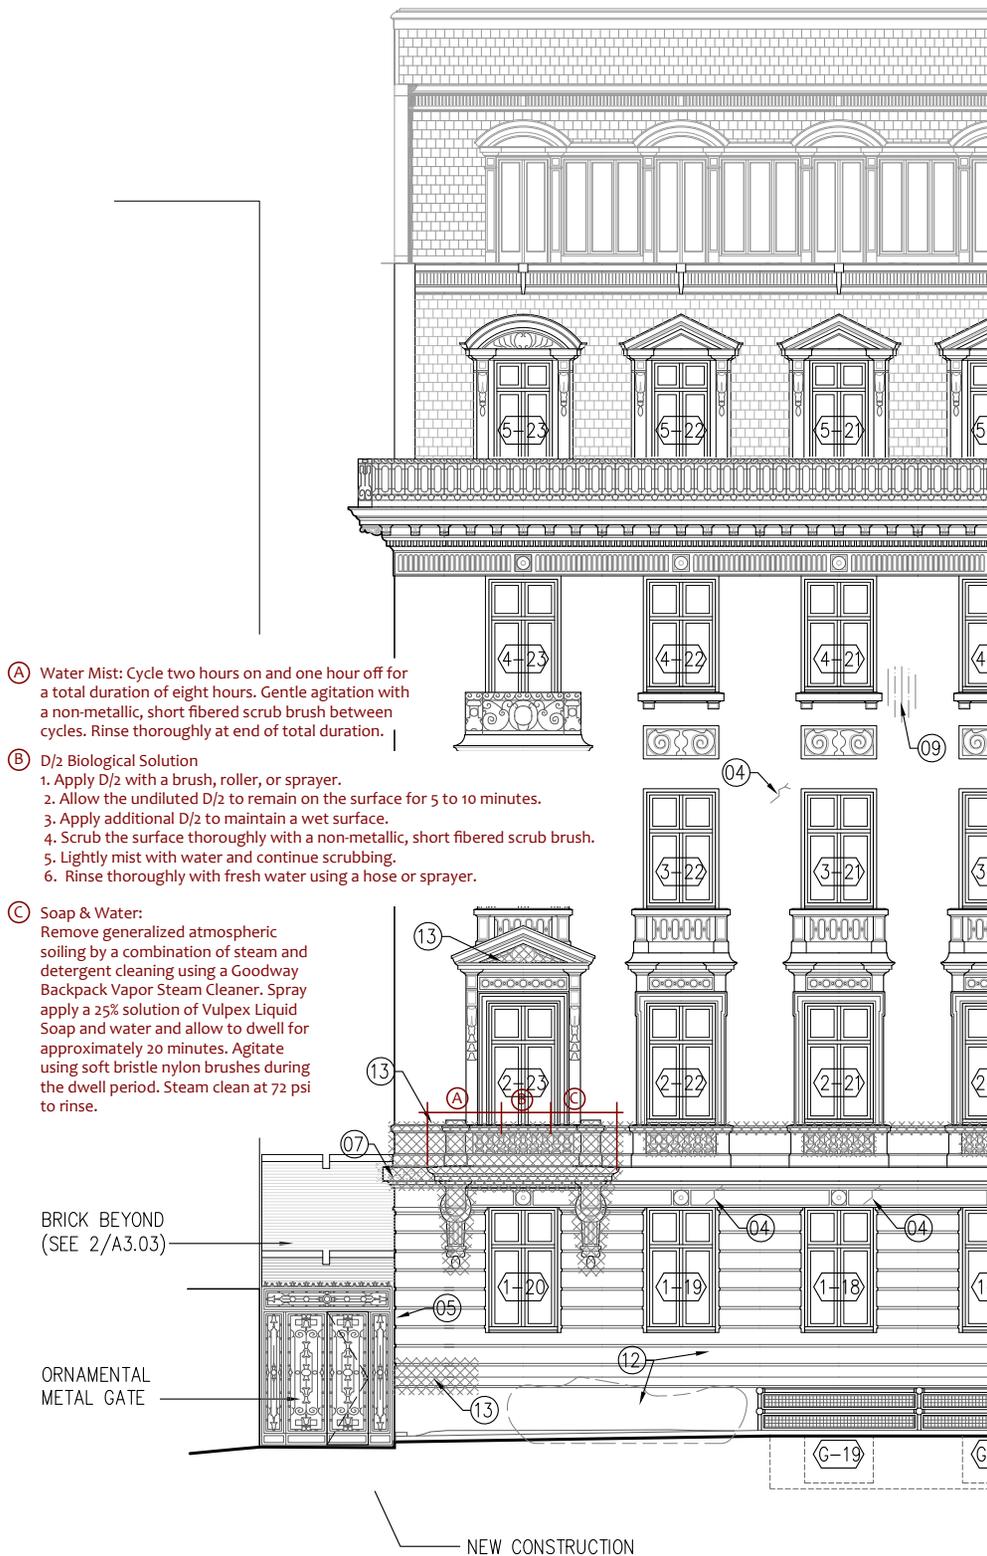
▲ before cleaning

The exterior facade of the building is limestone veneer with rusticated first floor and dressed limestone at the second through fourth floors with carved window and door surrounds. Projecting balconies at the second floor have a limestone balustrade that needed cleaning. Samples of cleaning regimens were prepared and tested to determine the most effective, least intrusive means including steam cleaning, mist, hot water, and cold water with soap.

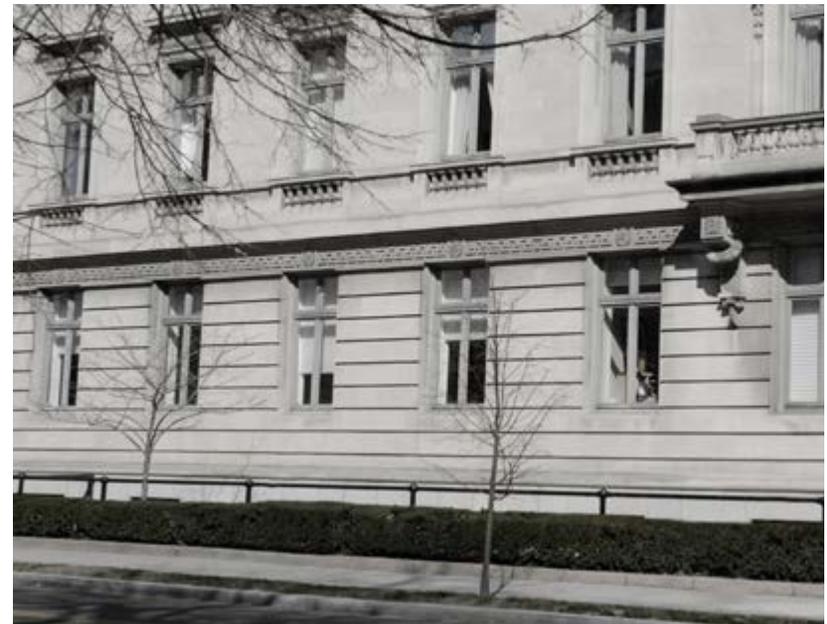
The existing main entrance at Massachusetts Avenue and 18th Street was not accessible. After studying several options, we created a new accessible entrance on P Street to align with the main north/south corridor. One existing window was converted into a new door by lowering the sill of the window to floor level and installing a lift that transports individuals from sidewalk level to the First Floor level. This solution avoids adversely affecting the appearance of the main entrance to the building.

▲ existing P Street elevation prior to construction

The design of the door respects the window pattern and the landing was supported independently of the existing building so as to be reversible in the future if necessary.

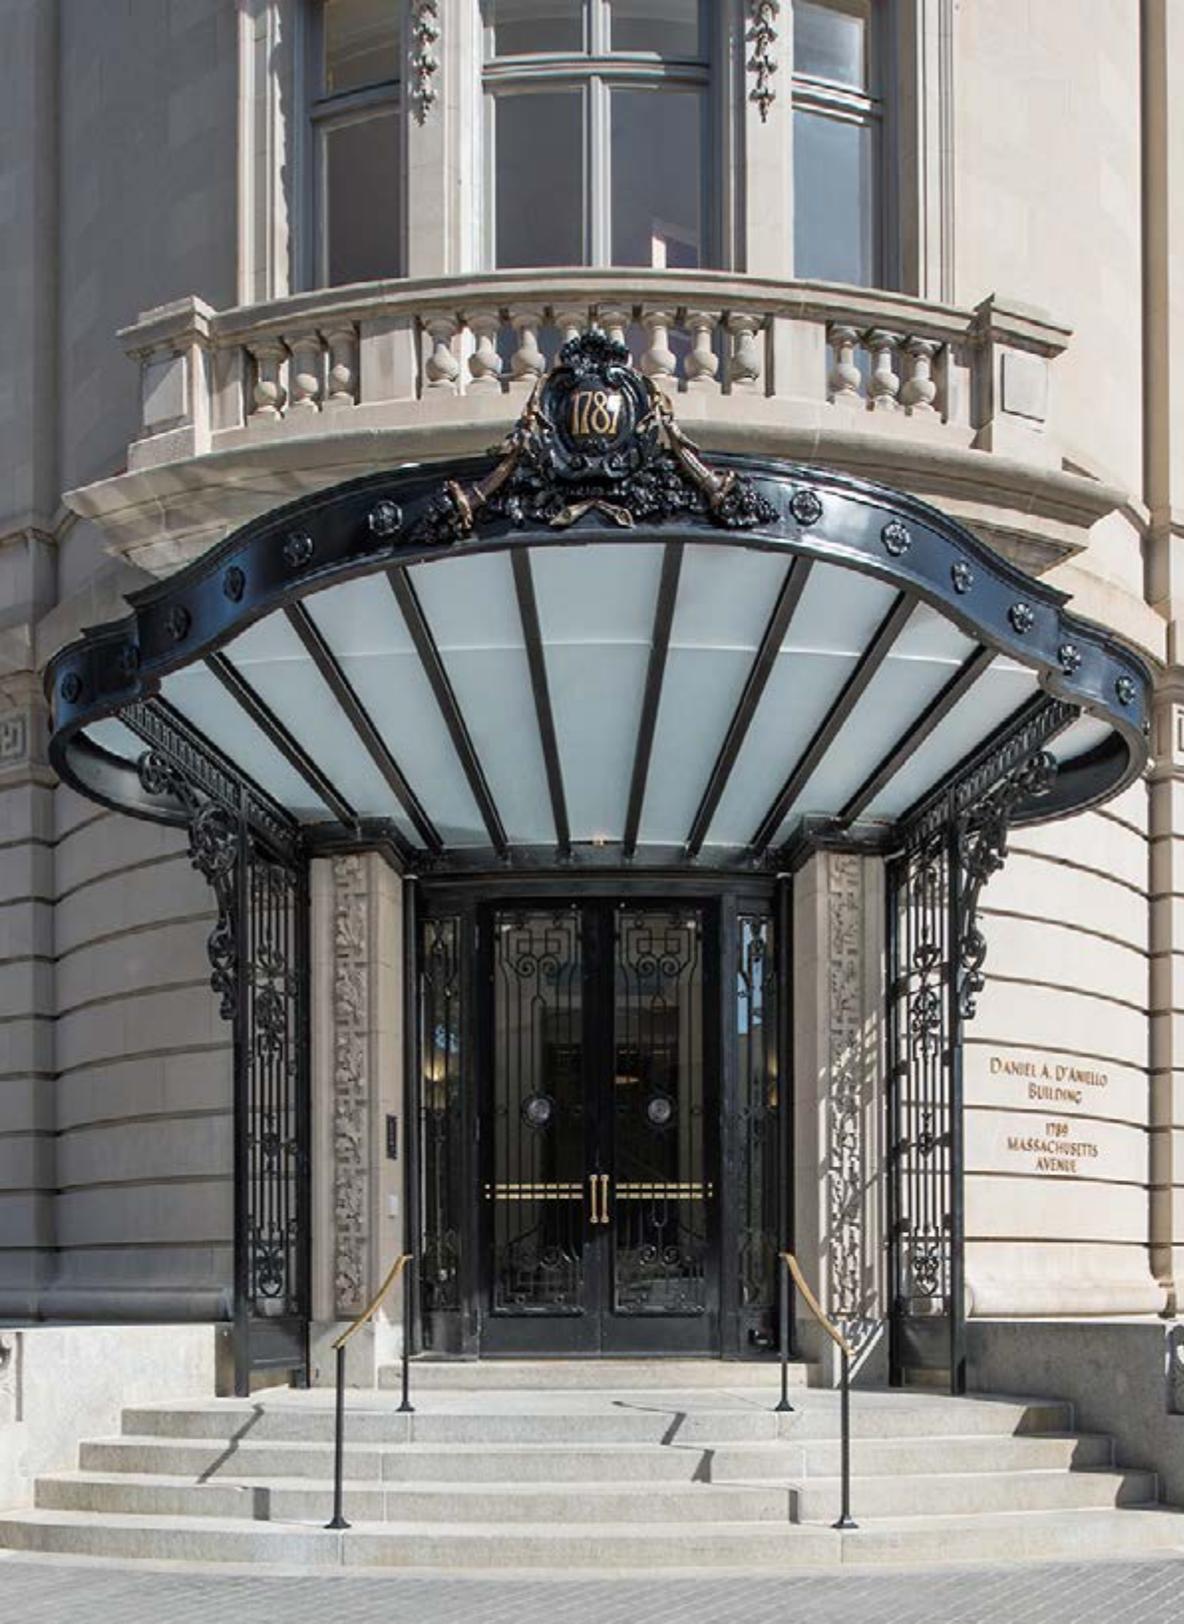
MAIN ENTRANCE

The decorative wrought-iron and glass canopy signals the entry to the building. It was in fair condition, however had broken glazing and the supports were deteriorating. Damaged or broken glazing was repaired/replaced in-kind and the metal was stripped and repainted. The structural integrity of the canopy supports was restored with new metal that matched the original profile.

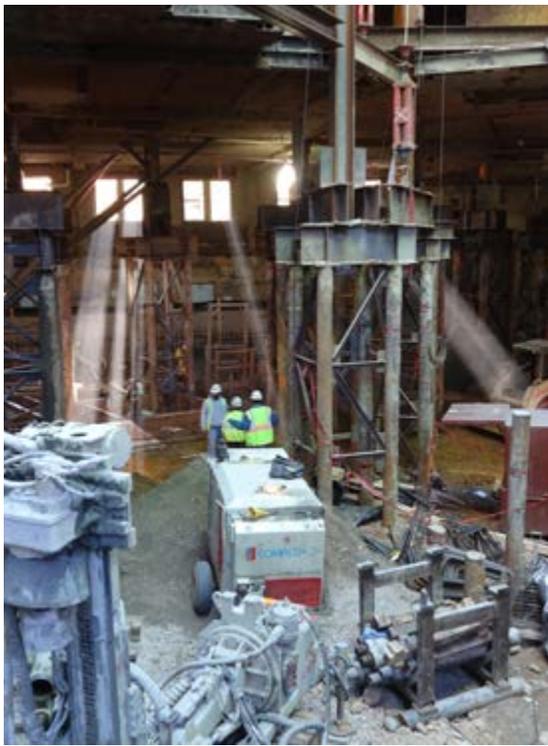
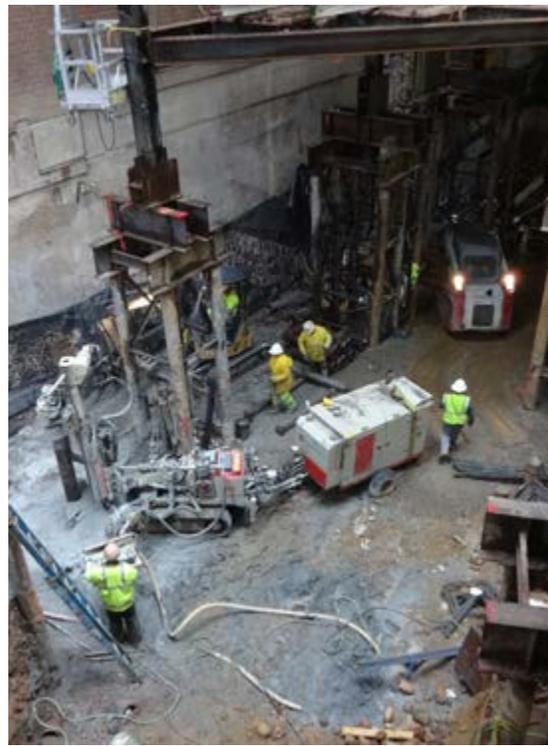
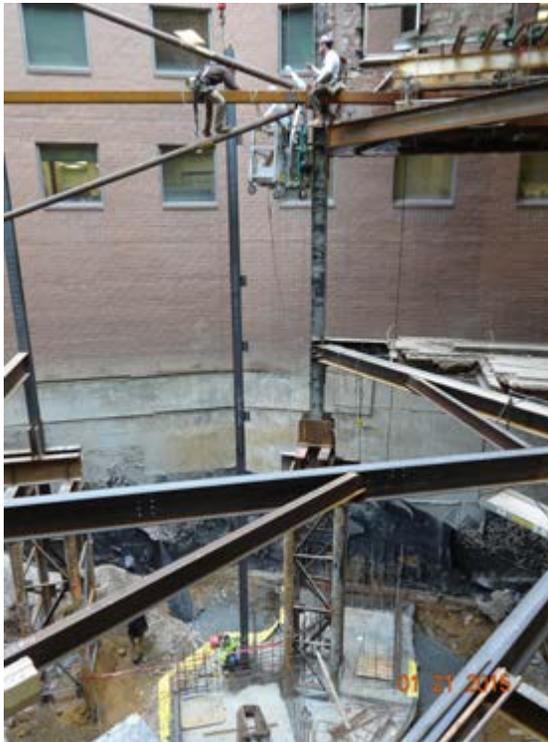
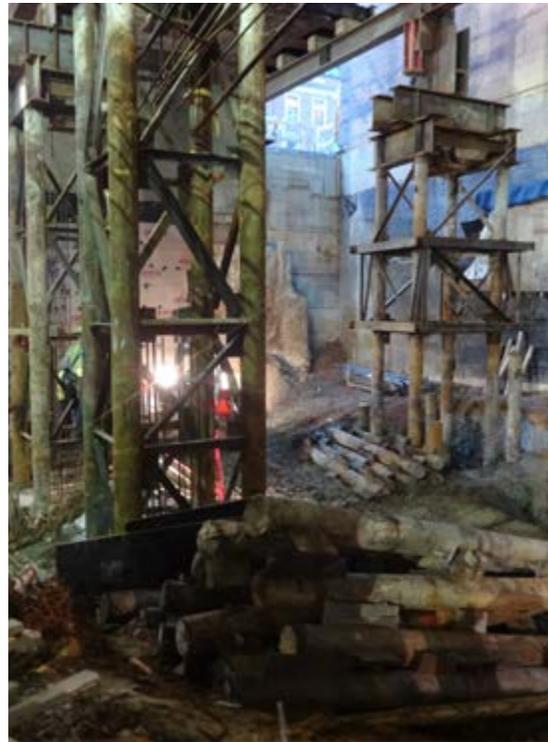
STRUCTURAL COMPLEXITY

To accommodate the AEI program on the constrained lot, we first constructed a new level below the entirety of the existing building. This was done by underpinning all of the structural columns and exterior walls, digging down to the new level, and constructing new foundations and the new floor and walls. By design, only a de minimis amount of settlement occurred (less than planned) and we avoided cracking the facades and walls.

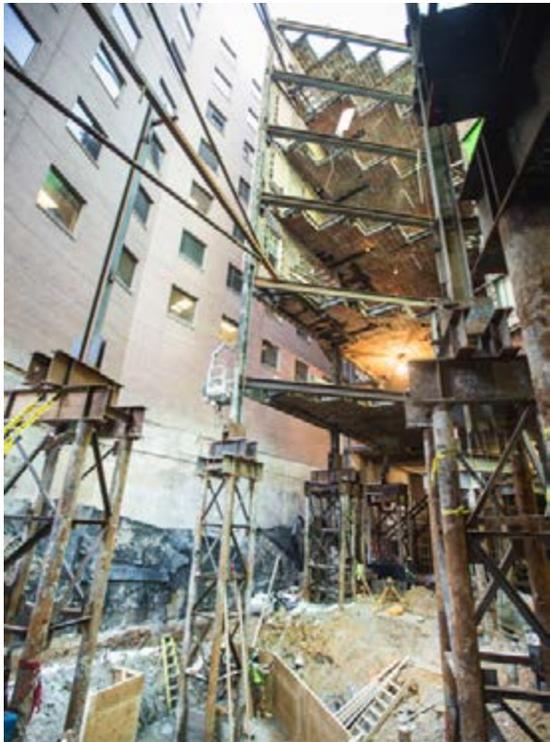
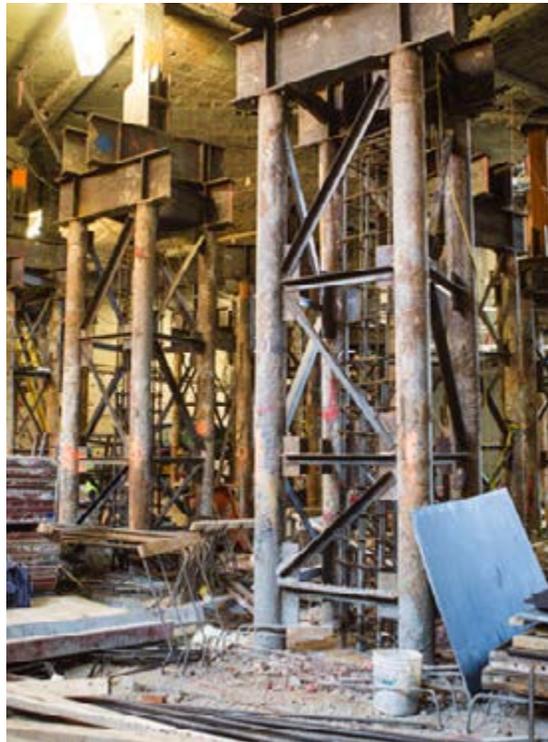
As we began to renovate the building, we found that much of the steel structure was not of the size indicated in the original design documents. To meet code and support the new mechanical penthouse, many of the columns had to be reinforced by painstakingly welding plates on to the existing steel. This, of course, required carefully removing asbestos plaster in those areas.

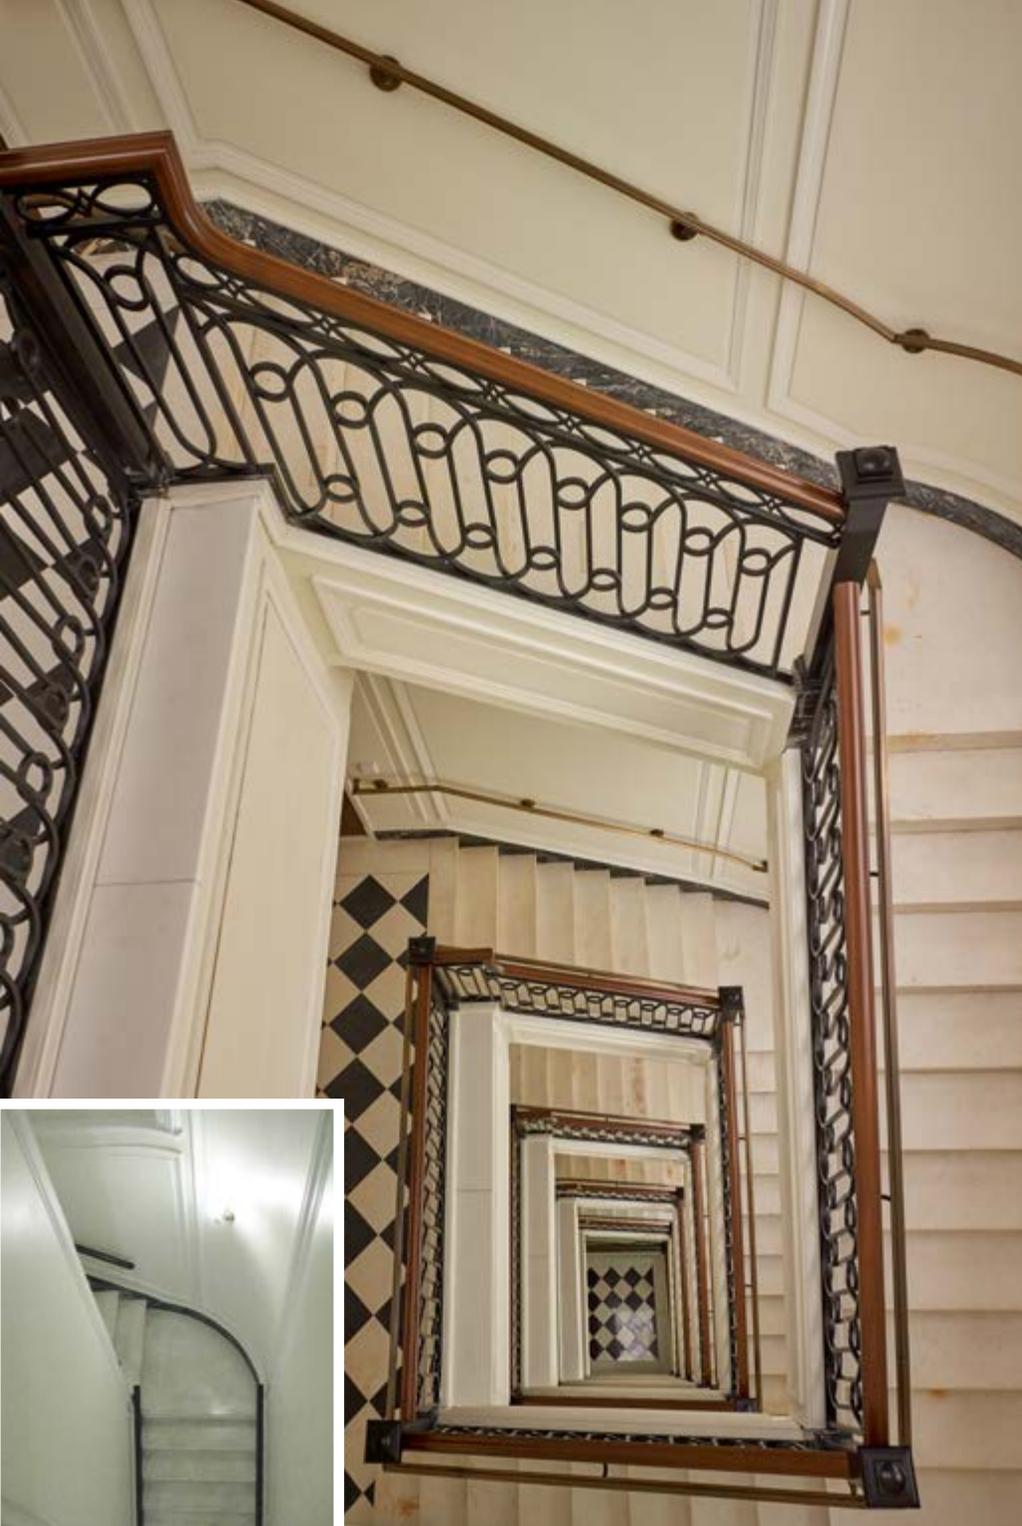
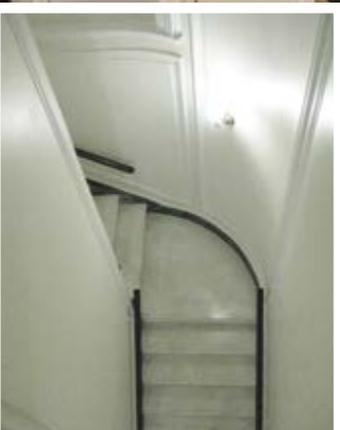
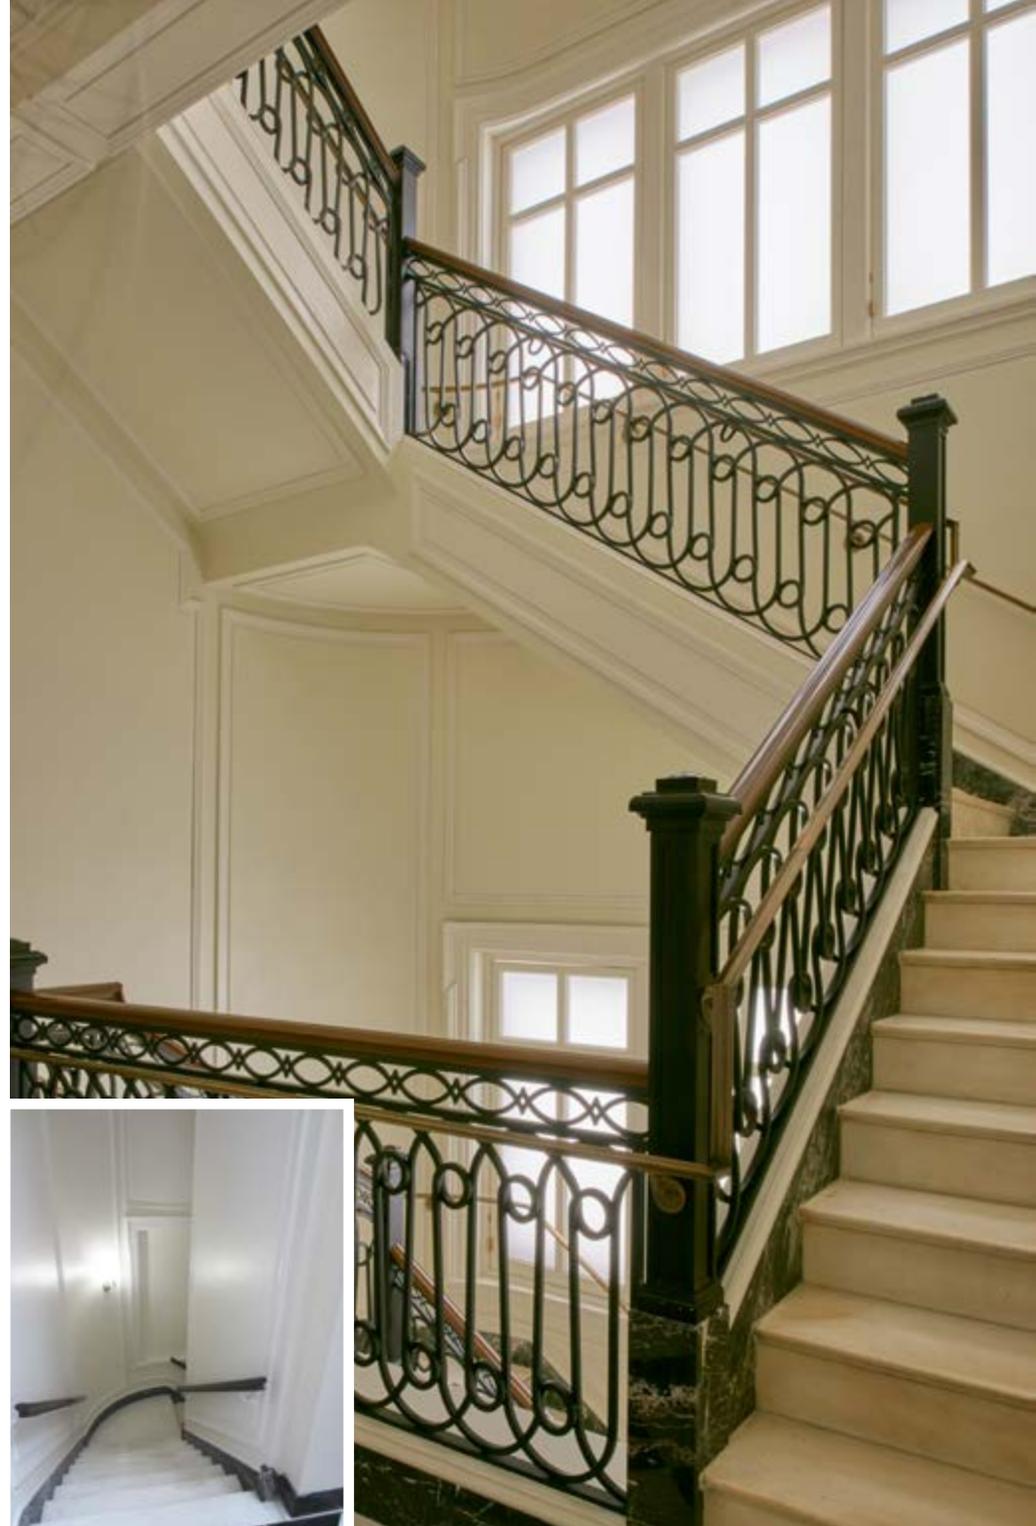
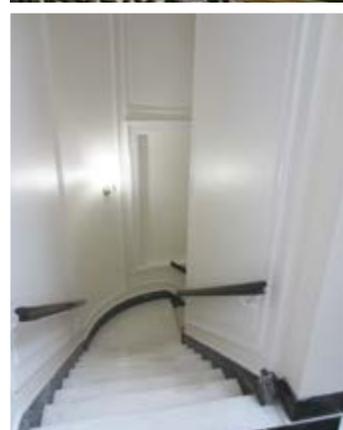
MONUMENTAL STAIR

The original central stair was constructed with a cage elevator in its center and with windows opening to a light well to provide light to the interior space. During the mid twentieth century, the elevator shaft had been enclosed and the windows had been removed (as the light well had been infilled). We returned the stair to a condition similar to its original by removing the closed elevator shaft and constructing new windows on every level. The windows are lit from behind to simulate natural light. The existing marble was cleaned, regouted, and repaired and a new guard rail and hand rail was installed. The stair is now an inviting means for the employees to travel among floors without taking the elevators.

▲ before construction

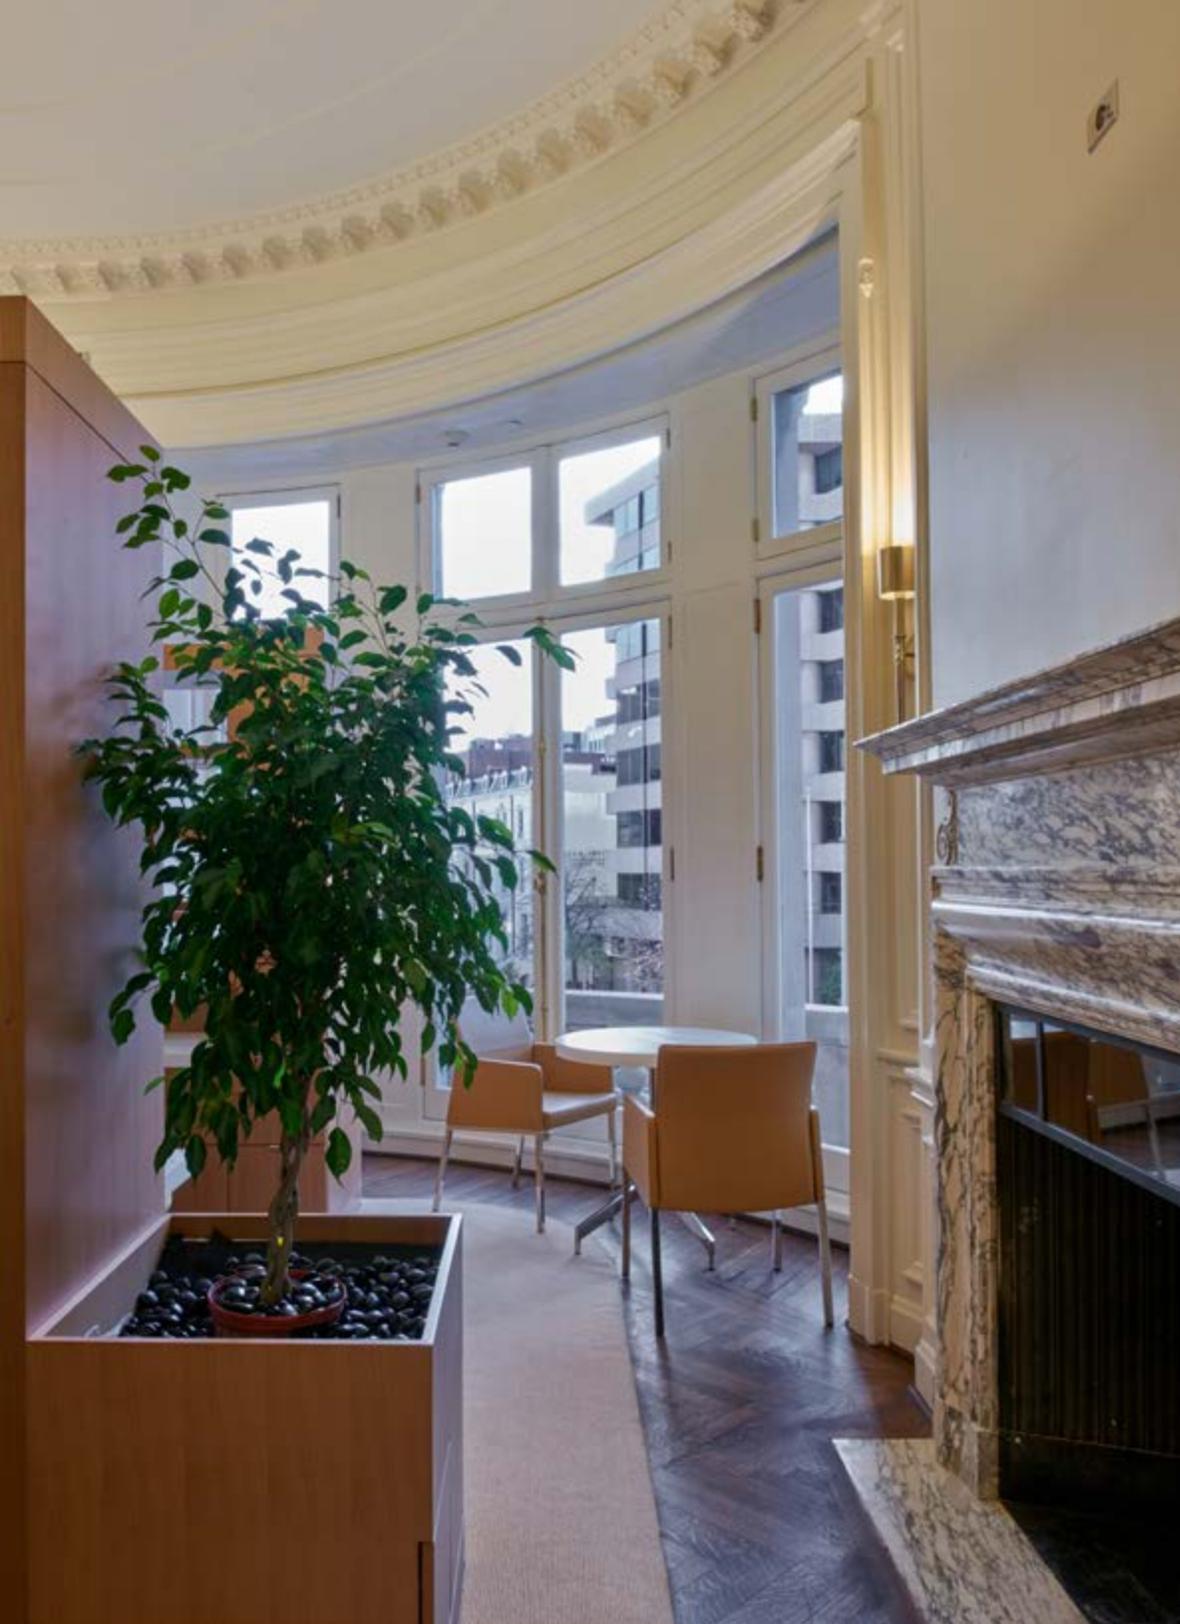
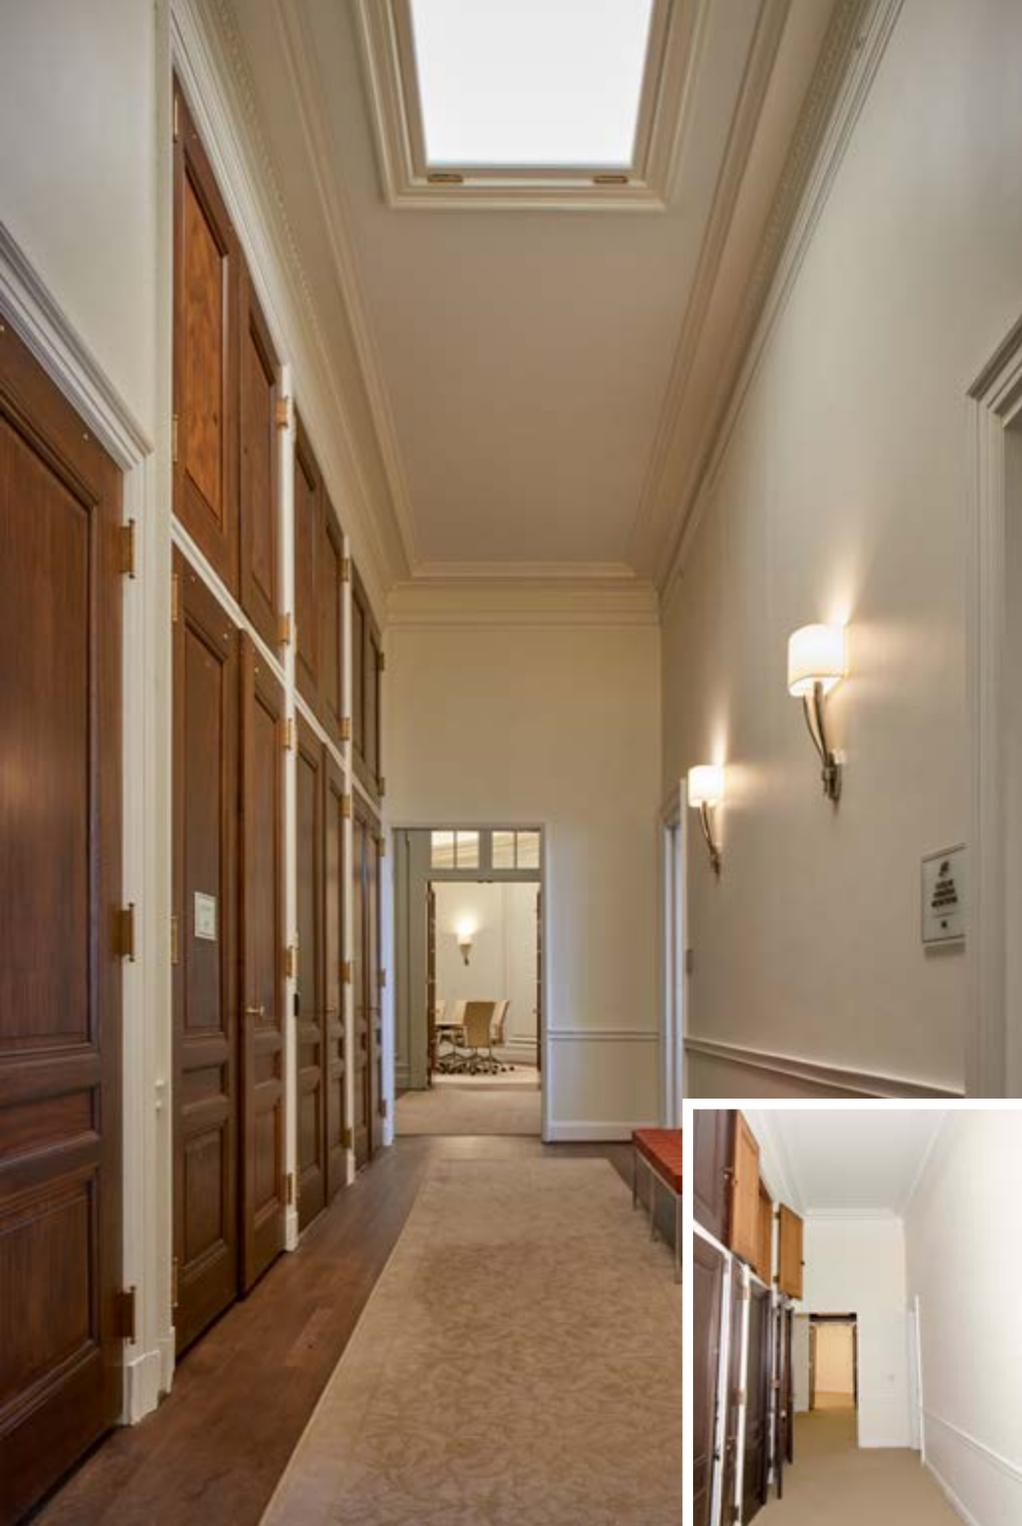
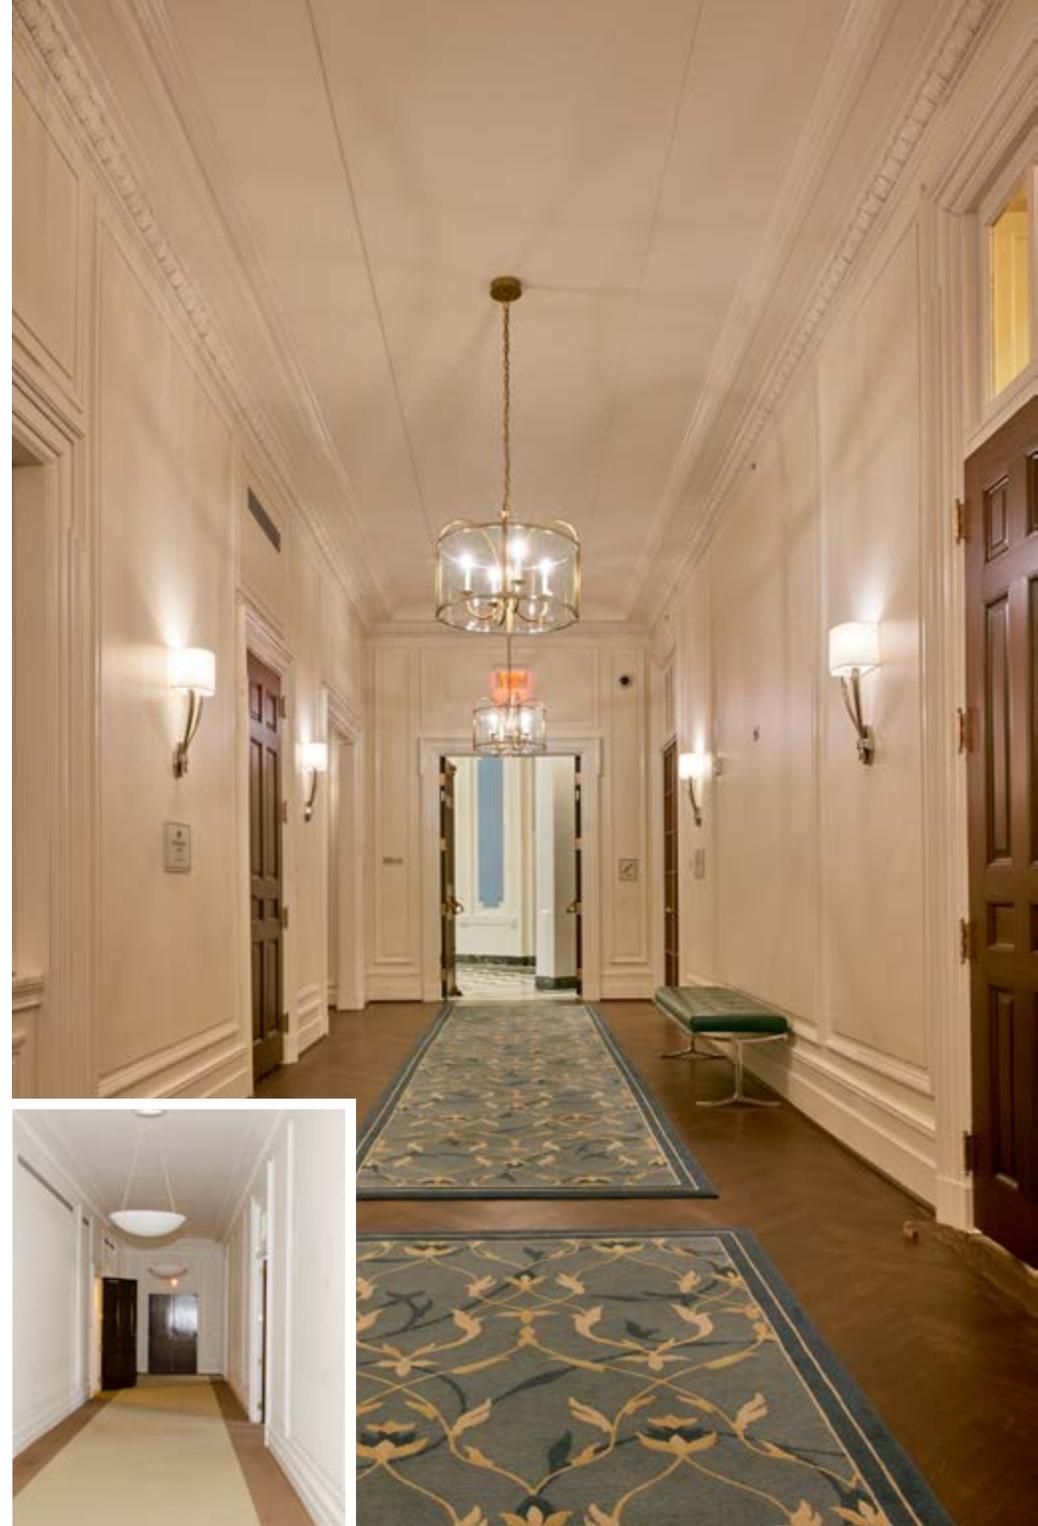
PLASTER CEILINGS & WALLS

The plaster ceilings and walls including all decorative moldings, cornices, coffers, decorative trim, and raised panels were retained to the greatest extent possible. Some walls were removed or reconfigured to allow for greater flexibility of the office layout. Where necessary, molds were created and plaster was recast when original details had been damaged or removed.

Unfortunately, all of the brown coat plaster in the building contained asbestos. Therefore, all holes in plaster walls for new MEP and structural systems had to be made in a contained area by an abatement company. This is a tedious phasing problem for the contractor but necessary for everyone's safety.
